# Pedestrian Mobility and Safety Study

New York City Department of Consumer Affairs

May 3, 2017

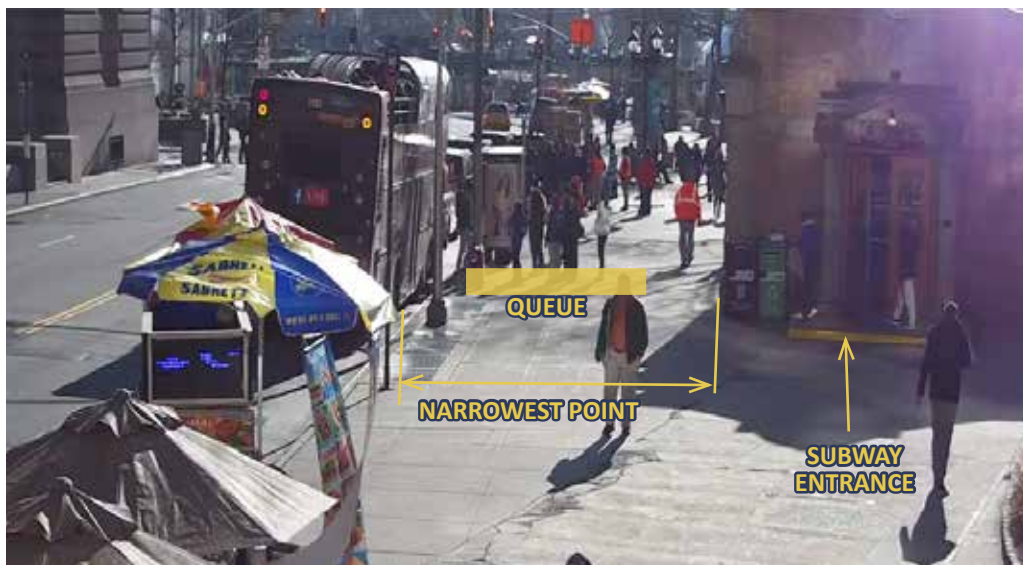
Thursday, December 22. 1:12 PM

Image 1: Weekday midday peak hour, sidewalk with queuing.

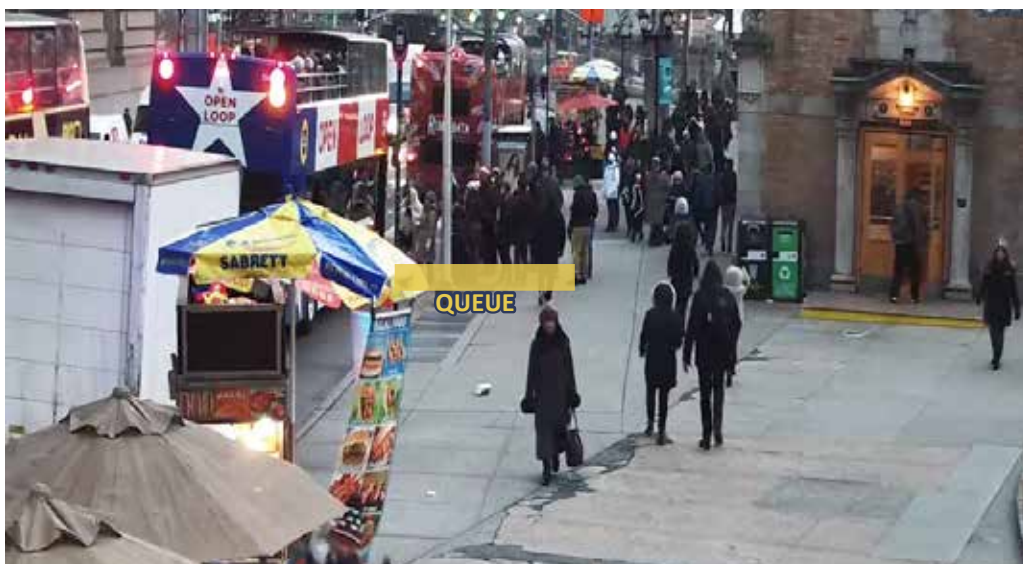
Wednesday, December 21. 4:21 PM

Image 2: Weekday pm peak hour, sidewalk with queuing.

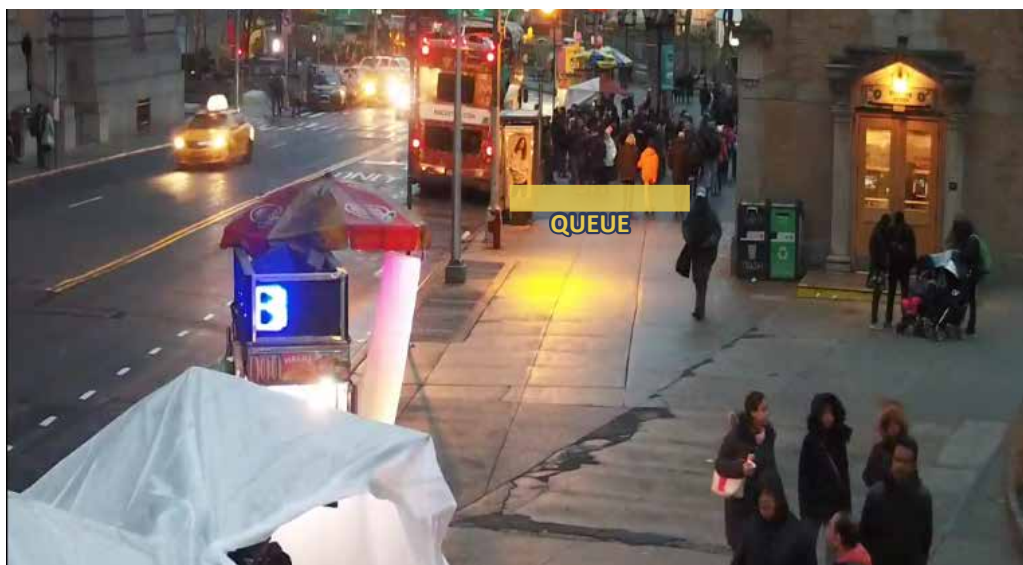
Monday, December 26 (Christmas Day observed) 4:33 PM

Image 3: Weekend peak hour, sidewalk with queuing.

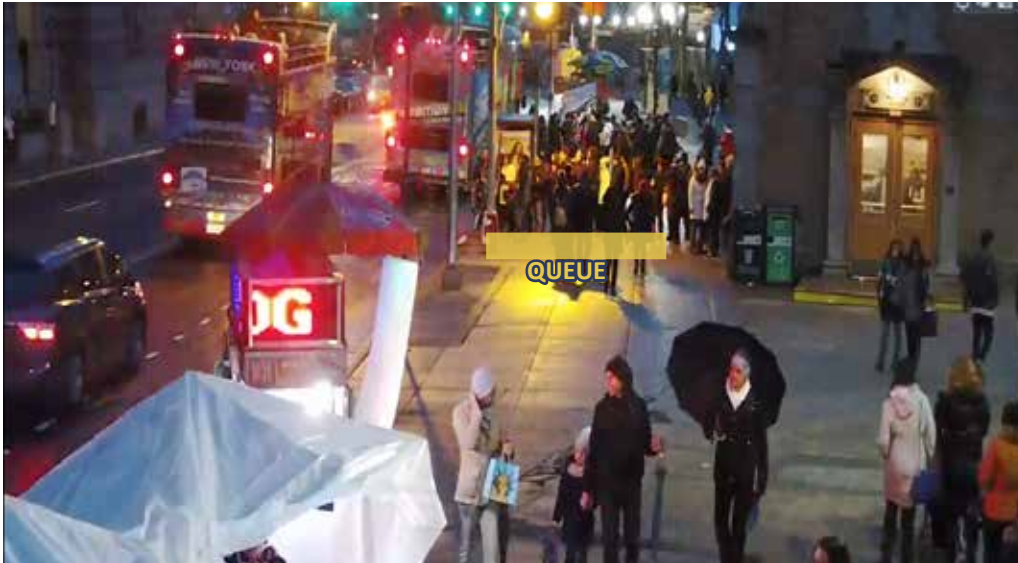
Monday, December 26 (Christmas Day observed) 4:45 PM

Image 4: Weekend peak hour, sidewalk with queuing.

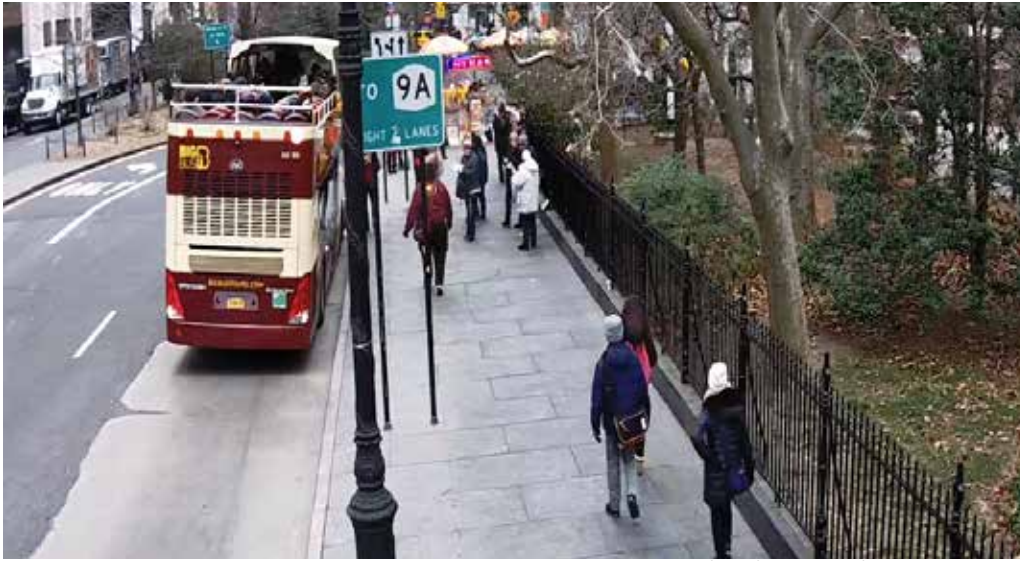
Wednesday, December 21. 12:45 PM

**Image 5: Weekday midday peak hour.**

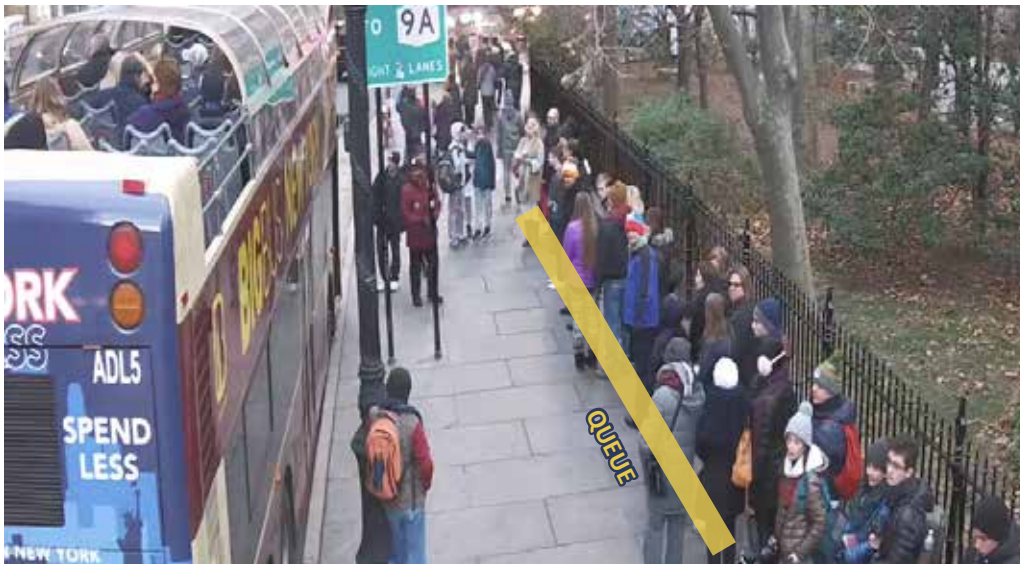
Thursday, December 22. 4:18 PM

**Image 6: Weekday PM peak hour, sidewalk with queuing adjacent to fence.**

Queues were typically organized along the fence side of the sidewalk at the narrowest point. Traffic signs located adjacent to the curb at this location further reduced the available pedestrian space. As shown in **Image 6**, the queuing area obstructed roughly half of the remaining effective width. This resulted in significant limitation of walking space for pedestrians. **Image 7** shows the sidewalk condition when the queue snakes around and blocks the entire width of the sidewalk during bus boarding. These photos illustrate a temporary condition that would last for several minutes during bus boarding. After accounting for this observed queuing behavior, the effective width of the sidewalk available for pedestrian flow would be 2 feet in the weekday PM peak hour, but would remain at 7.5 feet in the weekday midday peak hour.

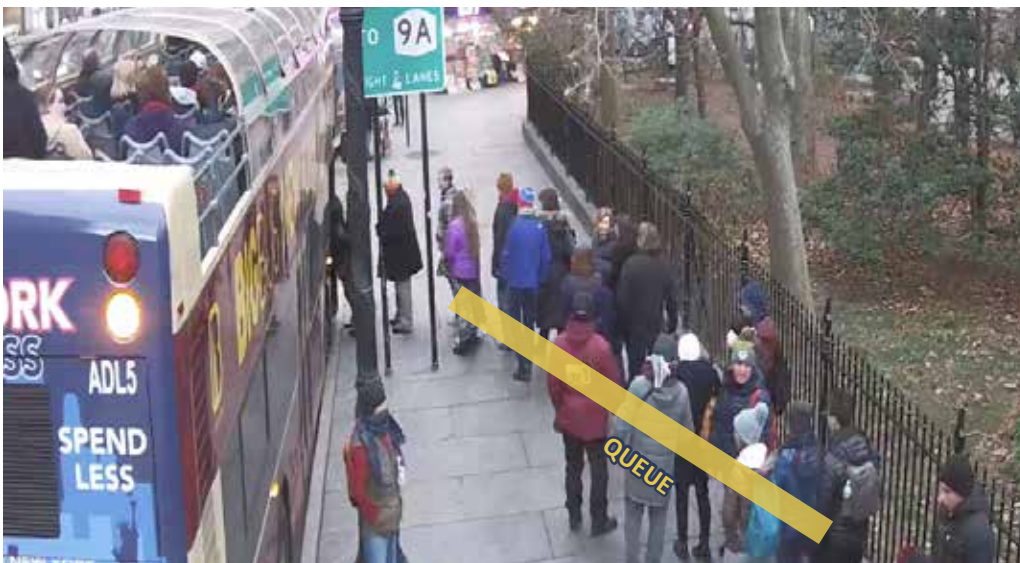
Thursday, December 22. 4:20 PM

**Image 7: Weekday PM peak hour, sidewalk with queuing adjacent to fence. Weekend peak hour, sidewalk during boarding.**

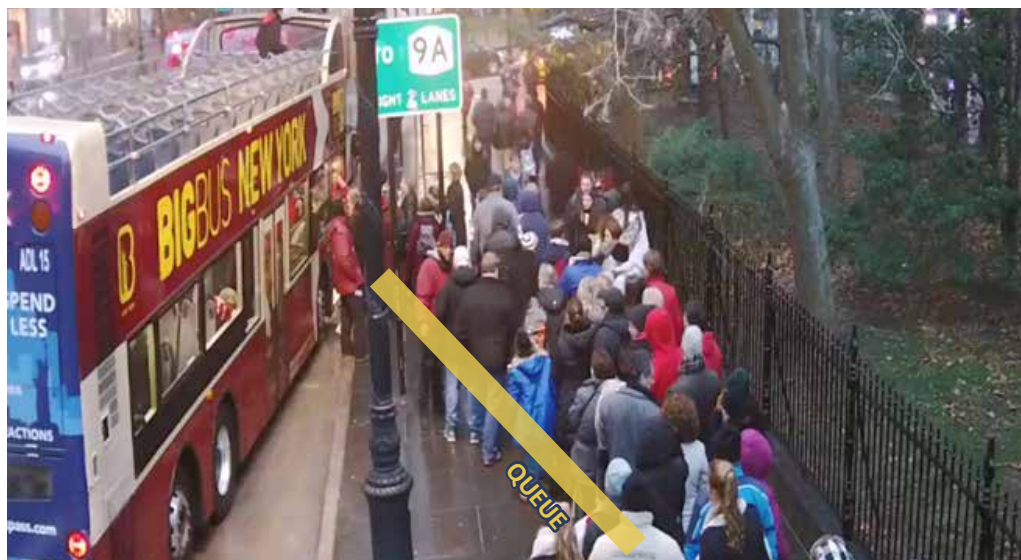
Monday, December 26 (Christmas Day observed) 4:32 PM

Image 8: Weekend peak hour, sidewalk during bus boarding.

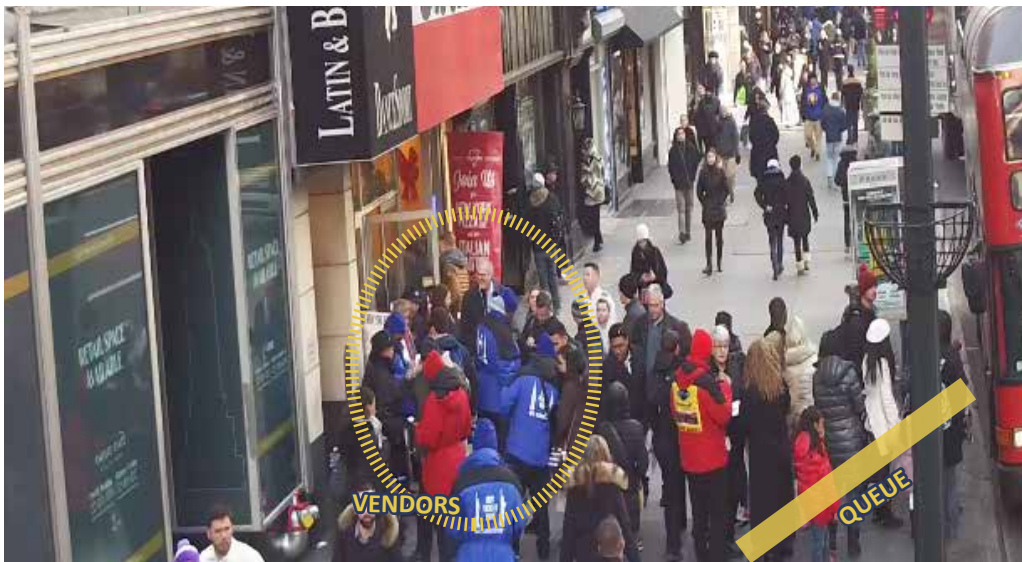
Thursday, December 22. 12:43 PM.

**Image 9: Weekday midday peak hour, ticket vending activities and clustering creating choke point on West 34th Street sidewalk.**

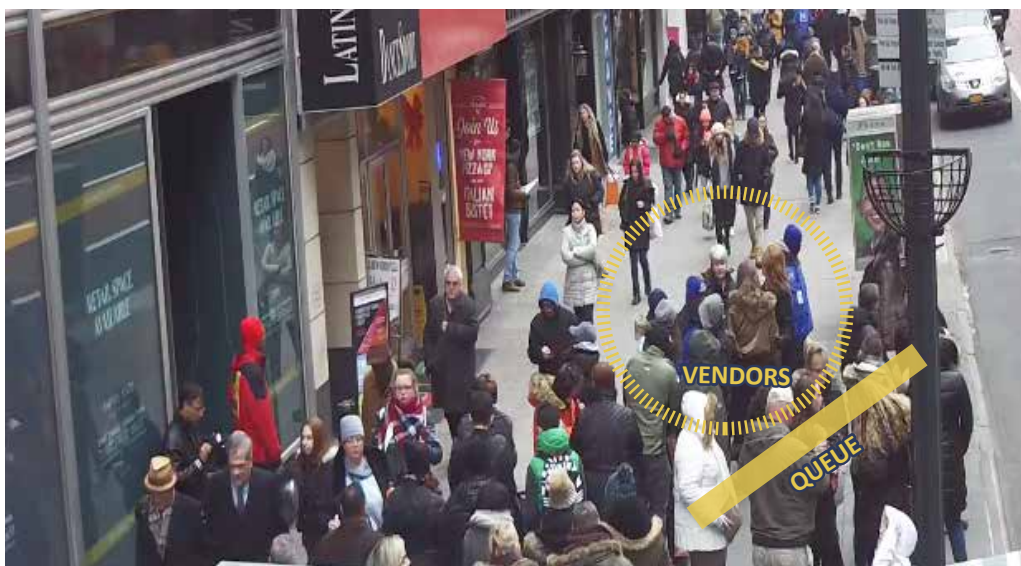
Wednesday, December 21. 12:57 PM.

**Image 10: Weekday midday peak hour, tour bus queuing behavior and ticket vending activity creating choke point on West 34th Street sidewalk.**

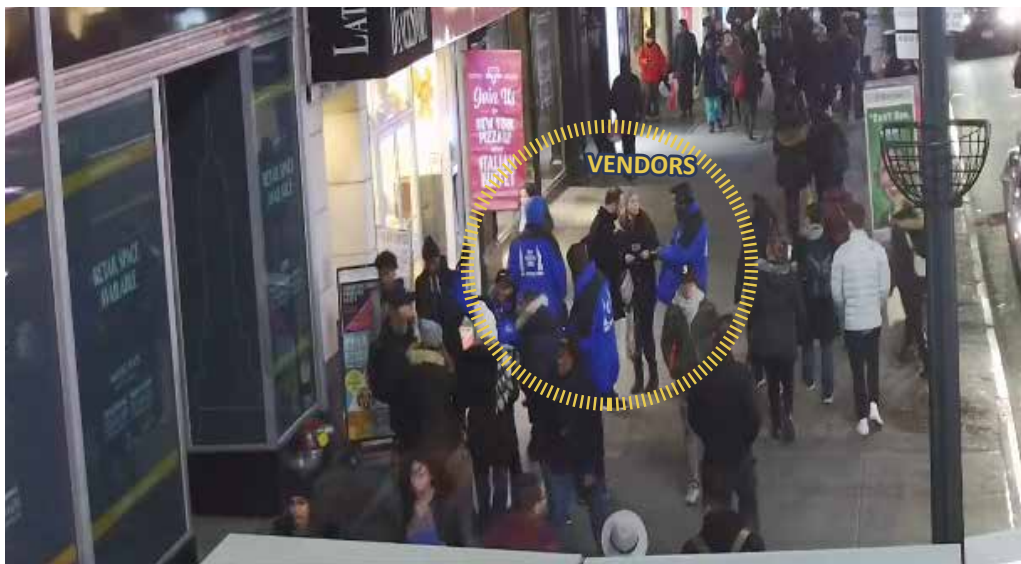
Wednesday, December 21. 5:42 PM.

**Image 11: Weekday PM peak hour, ticket vending activities creating choke point on West 34th Street sidewalk.**

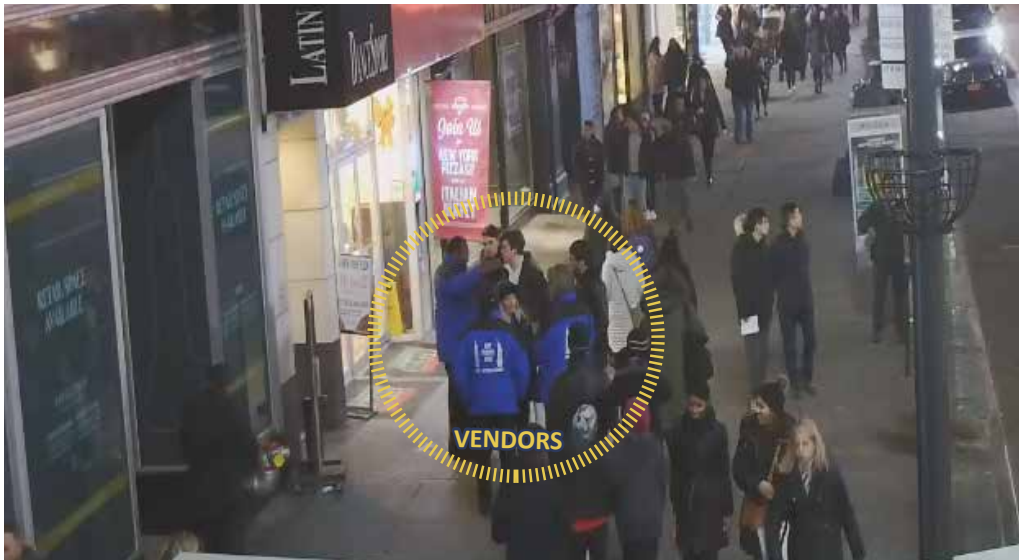
Thursday, December 22. 7:40 PM

**Image 12: Weekday PM peak hour, ticket vendor clustering and prospective customers creating an obstruction.**

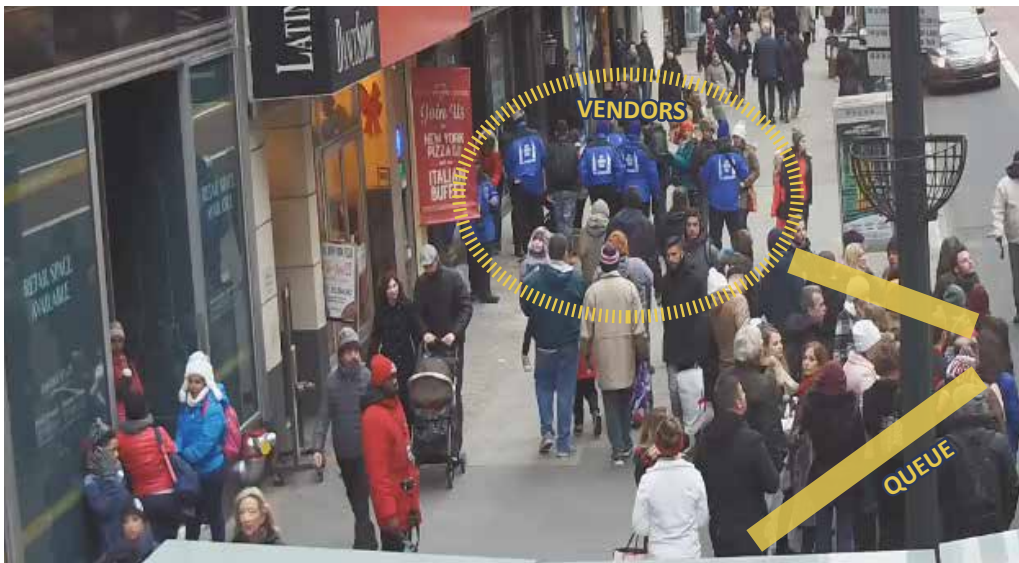
Monday, December 26 (Christmas Day observed). 12:51 PM

**Image 13: Weekend peak hour, ticket vendor clustering and prospective customers and queuing creating an obstruction.**

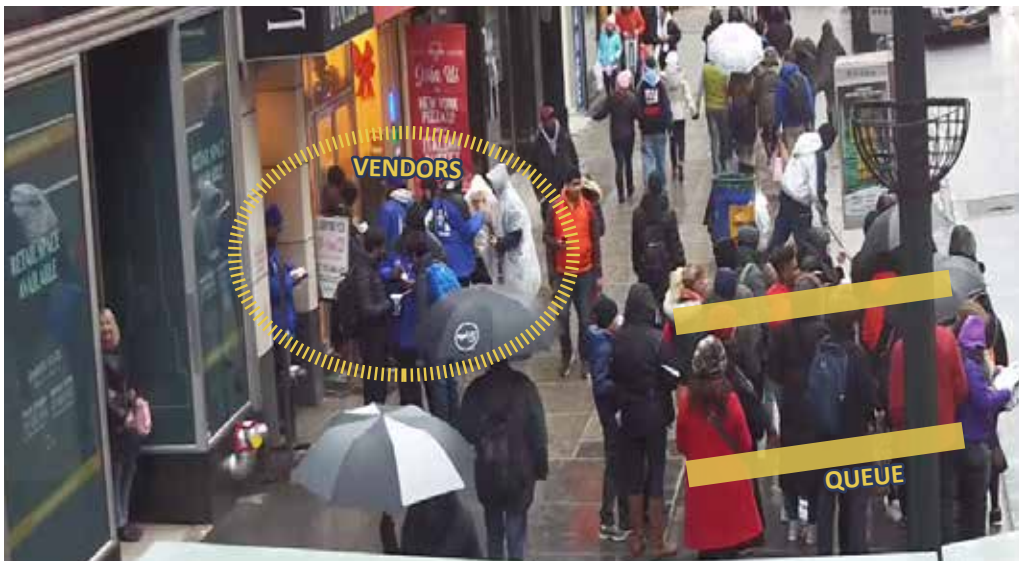
Monday, December 26 (Christmas Day observed). 2:37 PM

**Image 14: Weekend peak hour, ticket vending activities and tour bus queuing creating choke point.**

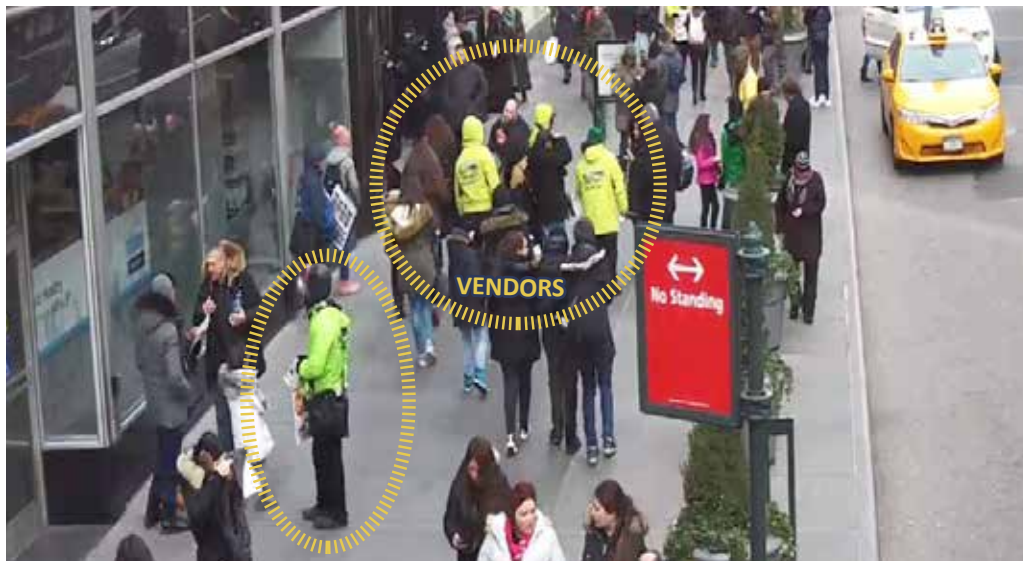
Wednesday, December 21. 11:12 AM

**Image 15: Weekday midday peak hour, ticket vending activities creating choke**

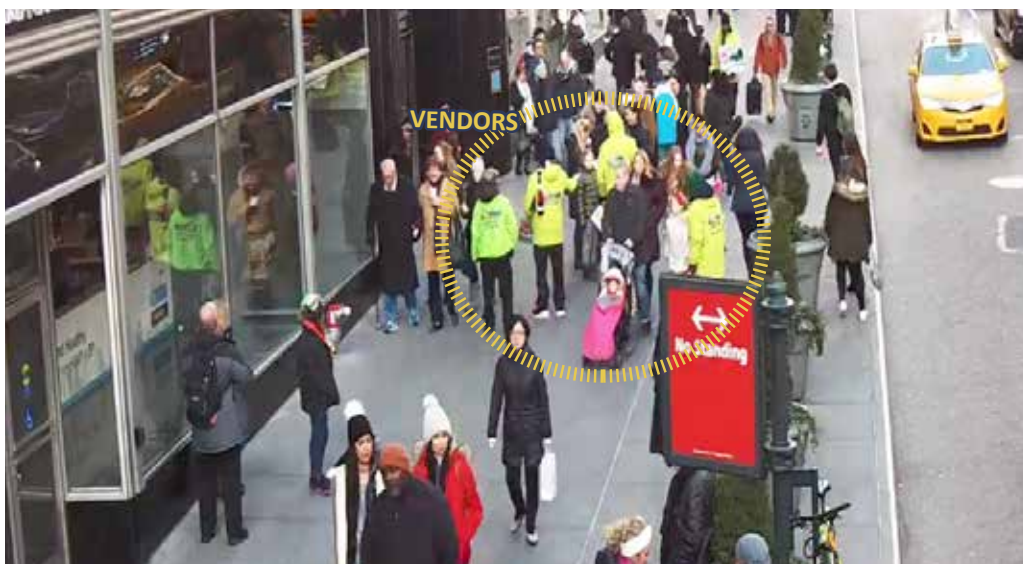
Thursday, December 22. 12:52 PM

**Image 16: Weekday midday peak hour, ticket vendors creating choke point during more congested conditions.**

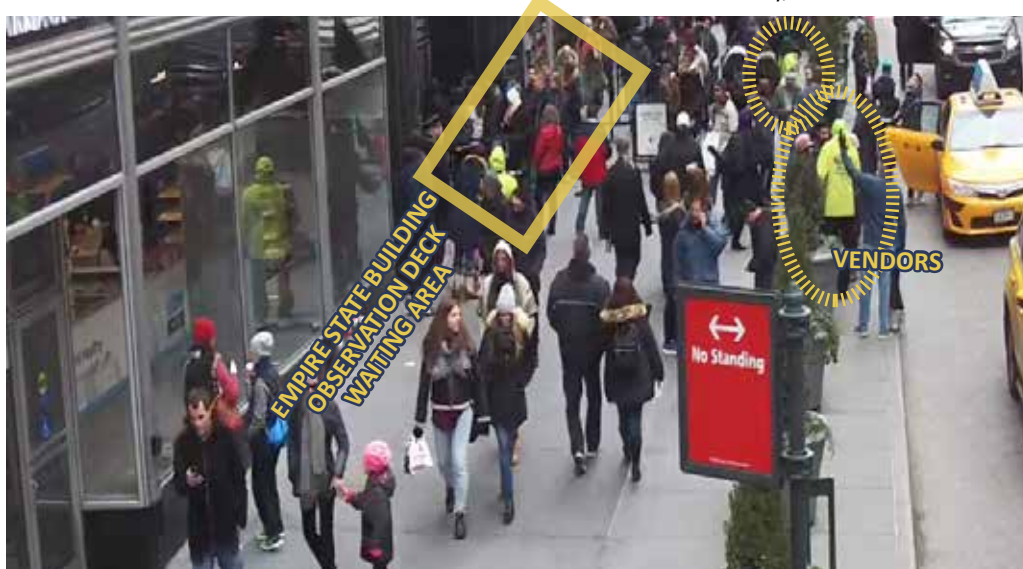
Monday, December 26, (Christmas Day observed). 4:22 PM

**Image 17: Weekend peak hour, Empire State Building observation deck queue creating choke point.**

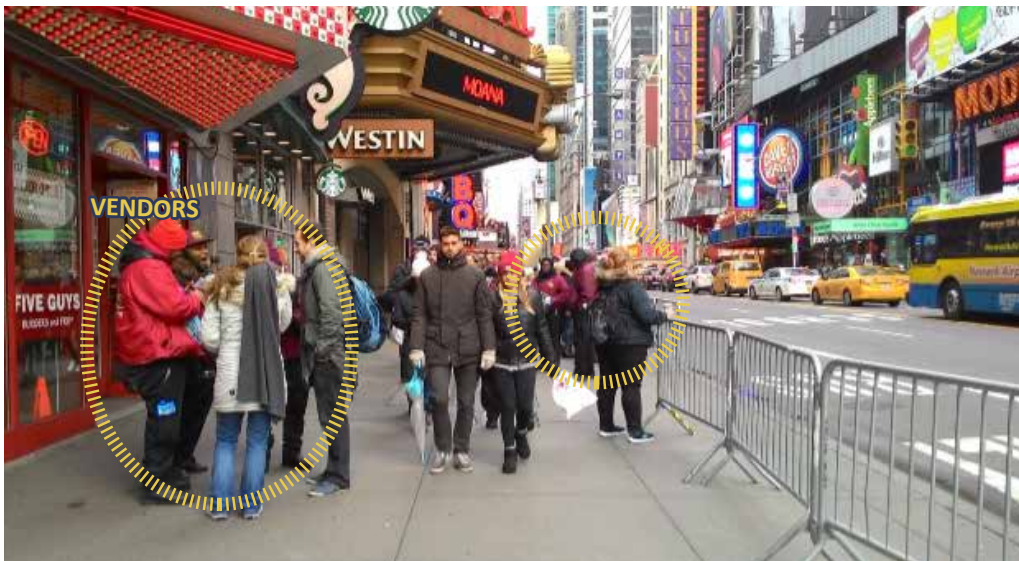
**Image 18: Preliminary field visit.**

During the preliminary field visit, ticket vendor were observed in front of the Five Guys Burger and Starbucks retail frontages as well as near the Big Bus Tours, The Ride, and Gray Line tour bus stops (**Image 18**). Vendors were observed to actively stop pedestrians and temporarily created a choke point in the sidewalk by doing so. Movable metal barricades had been placed by the curb provide a separation for tour bus queuing which formed parallel to the curb. This appeared to alleviate potential obstruction to pedestrian flows. After accounting for the passenger queuing area and other physical obstructions the effective width of the sidewalk for pedestrian travel was approximately 8 feet.

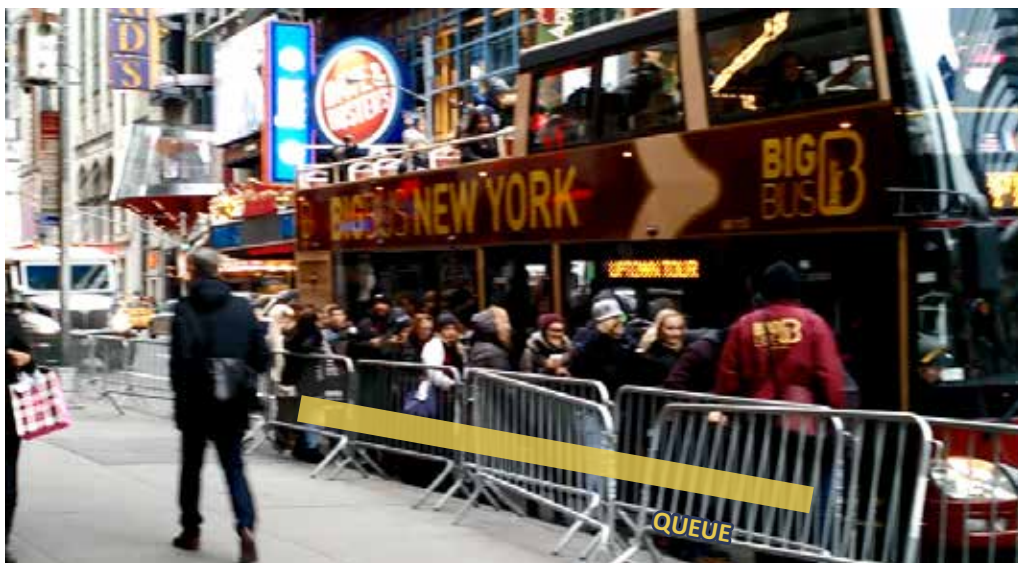
Thursday, December 22nd, 11:28 AM

Image 20: Weekday midday peak hour, tour bus queuing behavior.

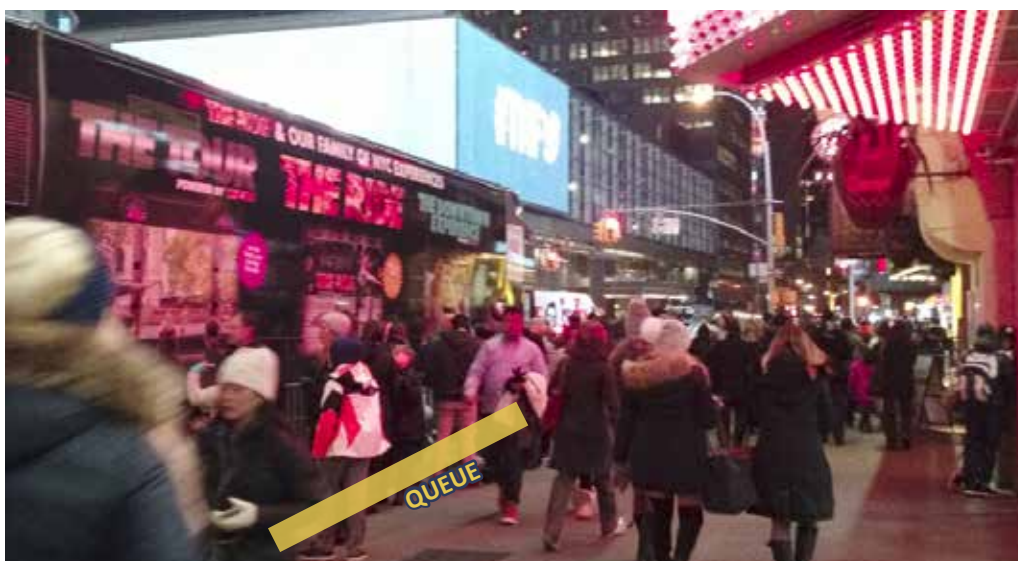
Wednesday, December 21st, 6:14 PM

Image 21: Weekday midday peak hour with queuing.

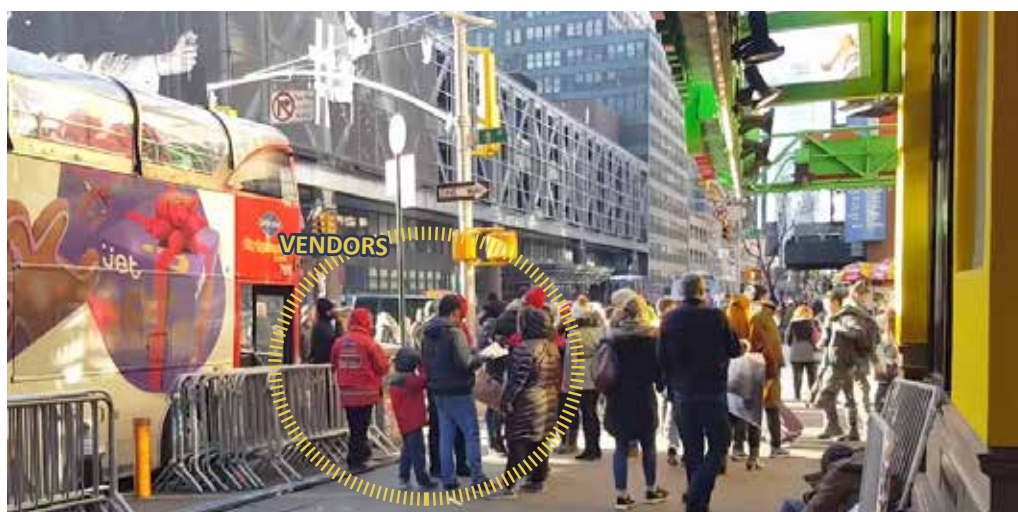
Sunday, January 1st, 4:27 PM.

Image 22: Weekend peak hour, Gray Line ticket vendor activities on north sidewalk of West 42nd Street between Eighth and Seventh Avenues.

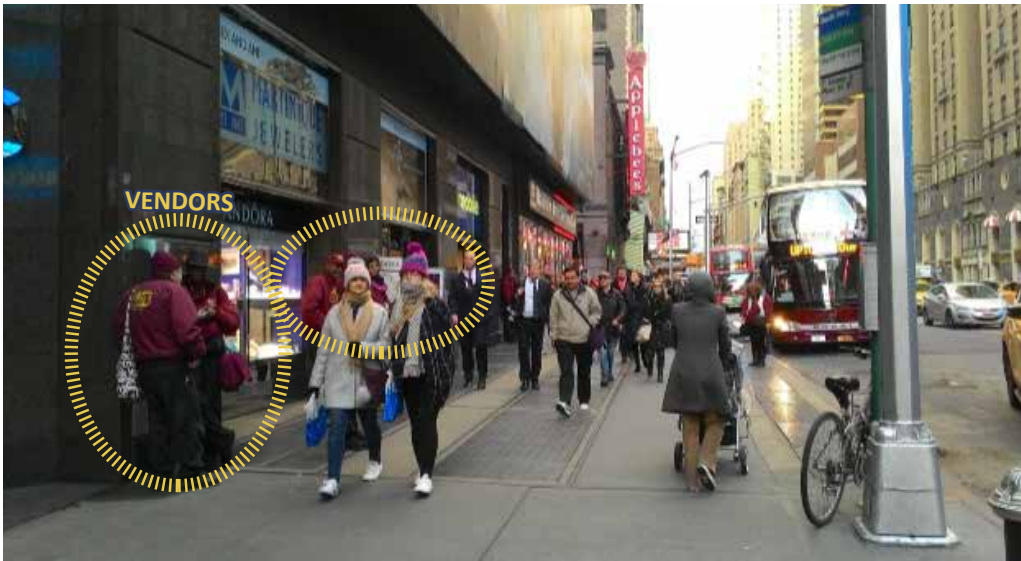
**Image 23: Preliminary field visit.**

During the preliminary field visit significant ticket vendor activities were observed (**Image 23**). Approximately seven Big Bus ticket vendors were observed to be active at this location, along with a number of ticket vendors for Gray Line, which has a nearby stop at West 50th Street. Ticket vendors were observed to be active in stopping pedestrians and talking to them, and tour bus personnel were active in organizing bus queues.

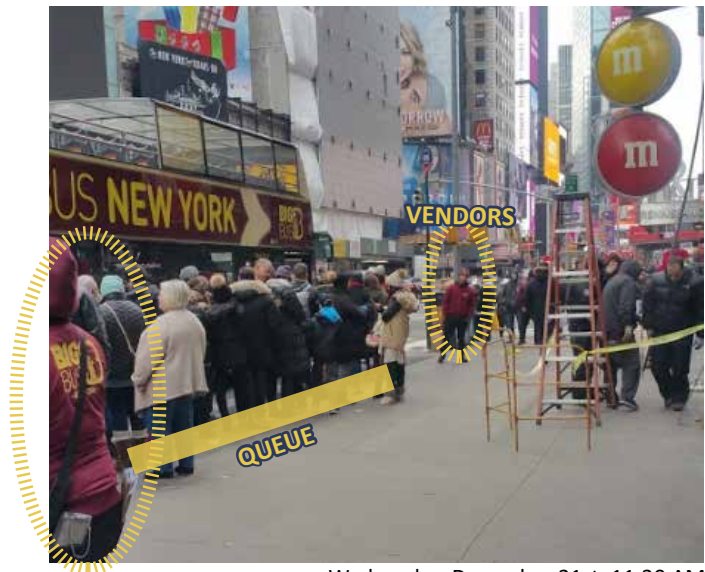
Wednesday, December 21st, 11:30 AM

**Image 25: Weekday midday peak hour, temporary construction at the M&M's store occurred from 11:00 AM to 11:40 AM, causing a sidewalk obstruction.**

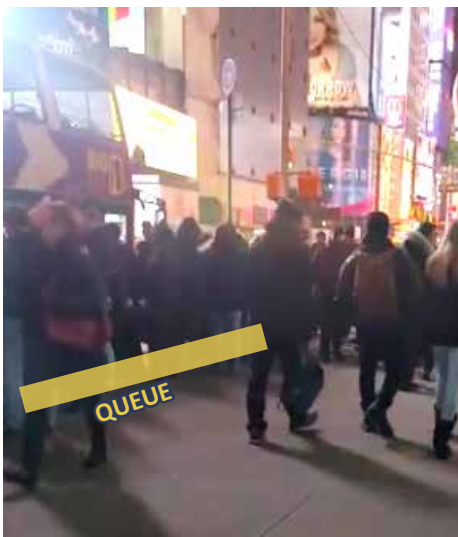
Wednesday, December 21st, 6:30 PM

**Image 26: Weekday PM peak hour. with queuing.**

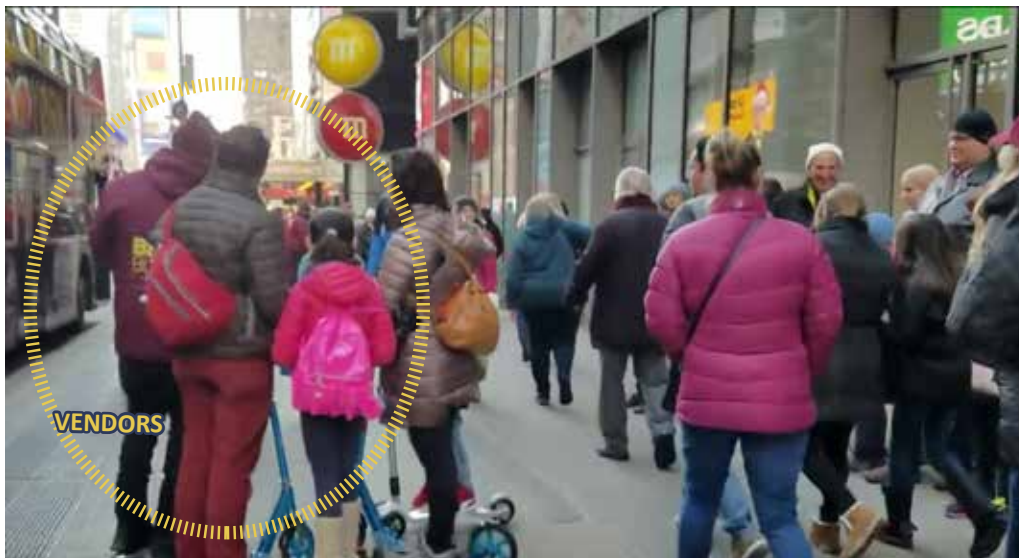
Sunday, January 1st. 1:30 PM

Image 27: Weekend day observation period, ticket vendor activity present.

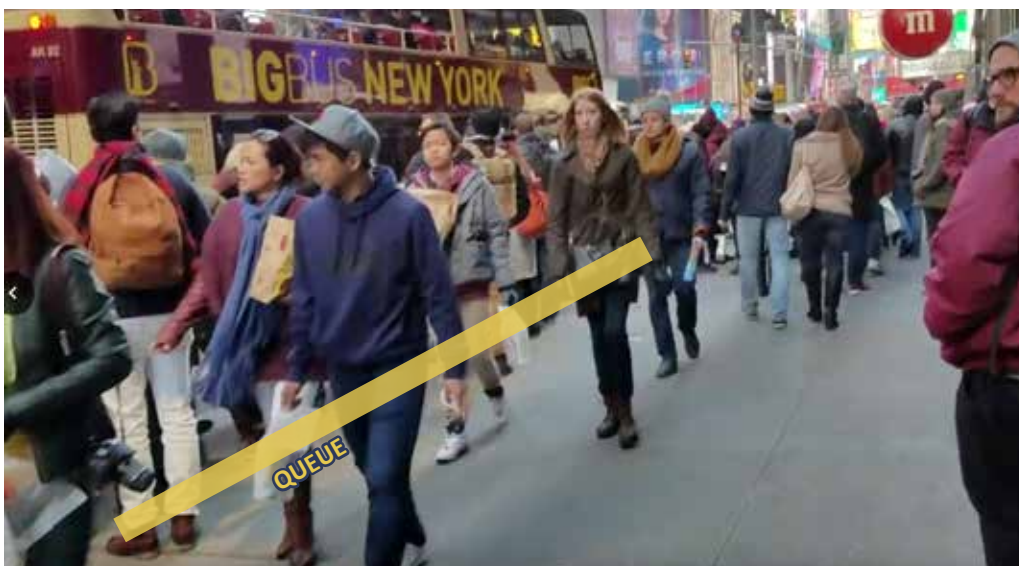
Sunday, January 1st. 2:45 PM

Image 28: Weekend day observation period, long queues along curb.

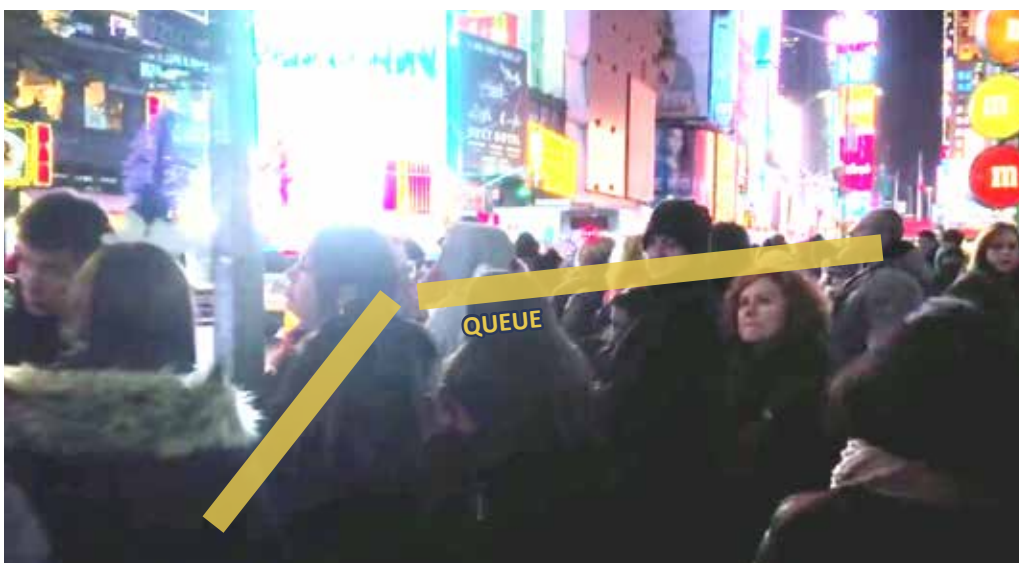
Sunday, January 1st. 5:45 PM

Image 29: Weekend peak hour, long queues along curb.

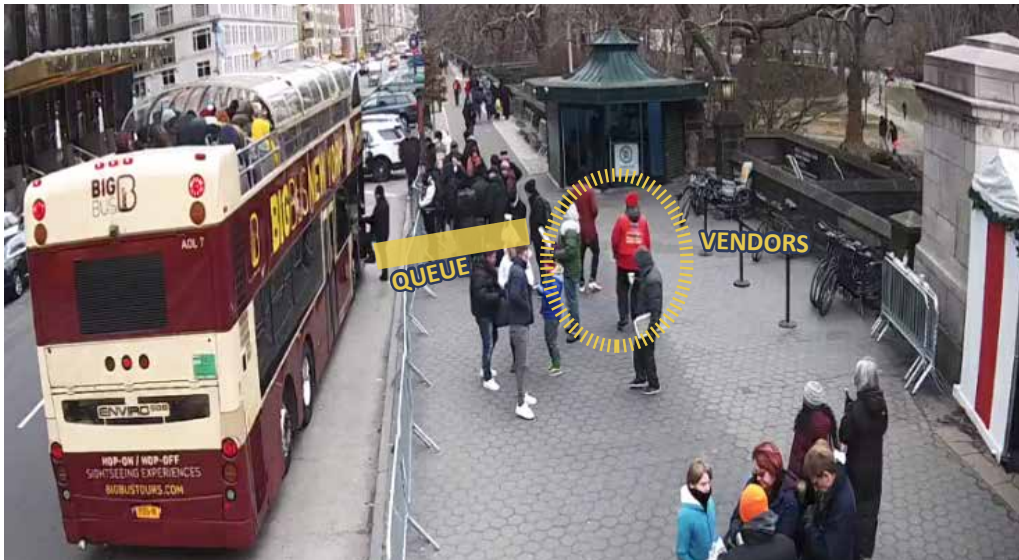
Wednesday, December 21. 11:53 AM

**Image 30: Weekday AM peak hour, tour bus queues partially block the sidewalk at narrowest point.**

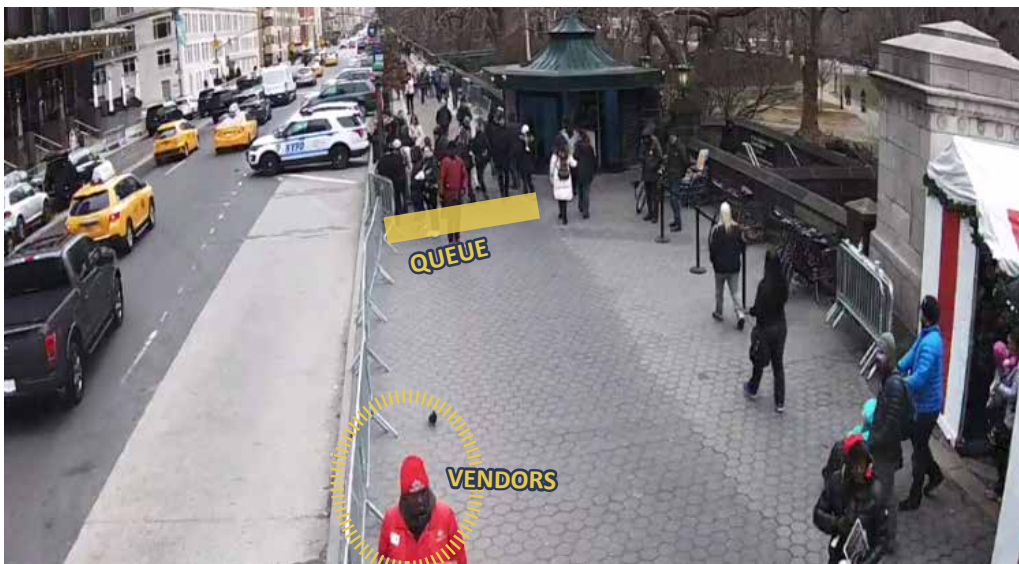
Wednesday, December 21. 11:36 AM

**Image 31: Weekday AM peak hour, tour bus queues fully block the sidewalk at narrowest point.**

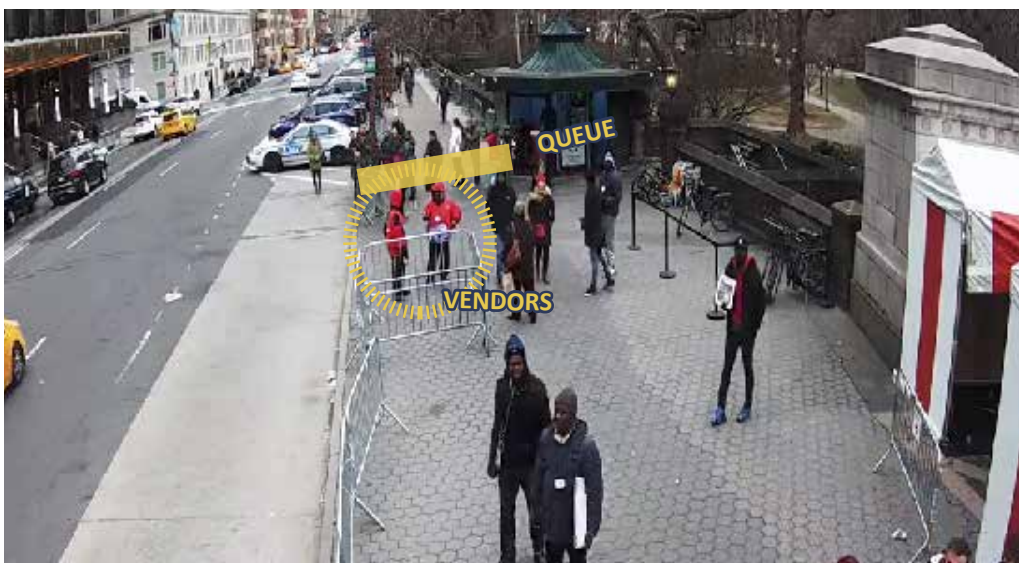
Monday, December 26 (Christmas Day observed). 12:38 PM

**Image 32: Weekend peak hour, tour bus queues fully block the sidewalk at narrowest point.**
