# Pedestrian Mobility and Safety Study

New York City Department of Consumer Affairs

May 3, 2017

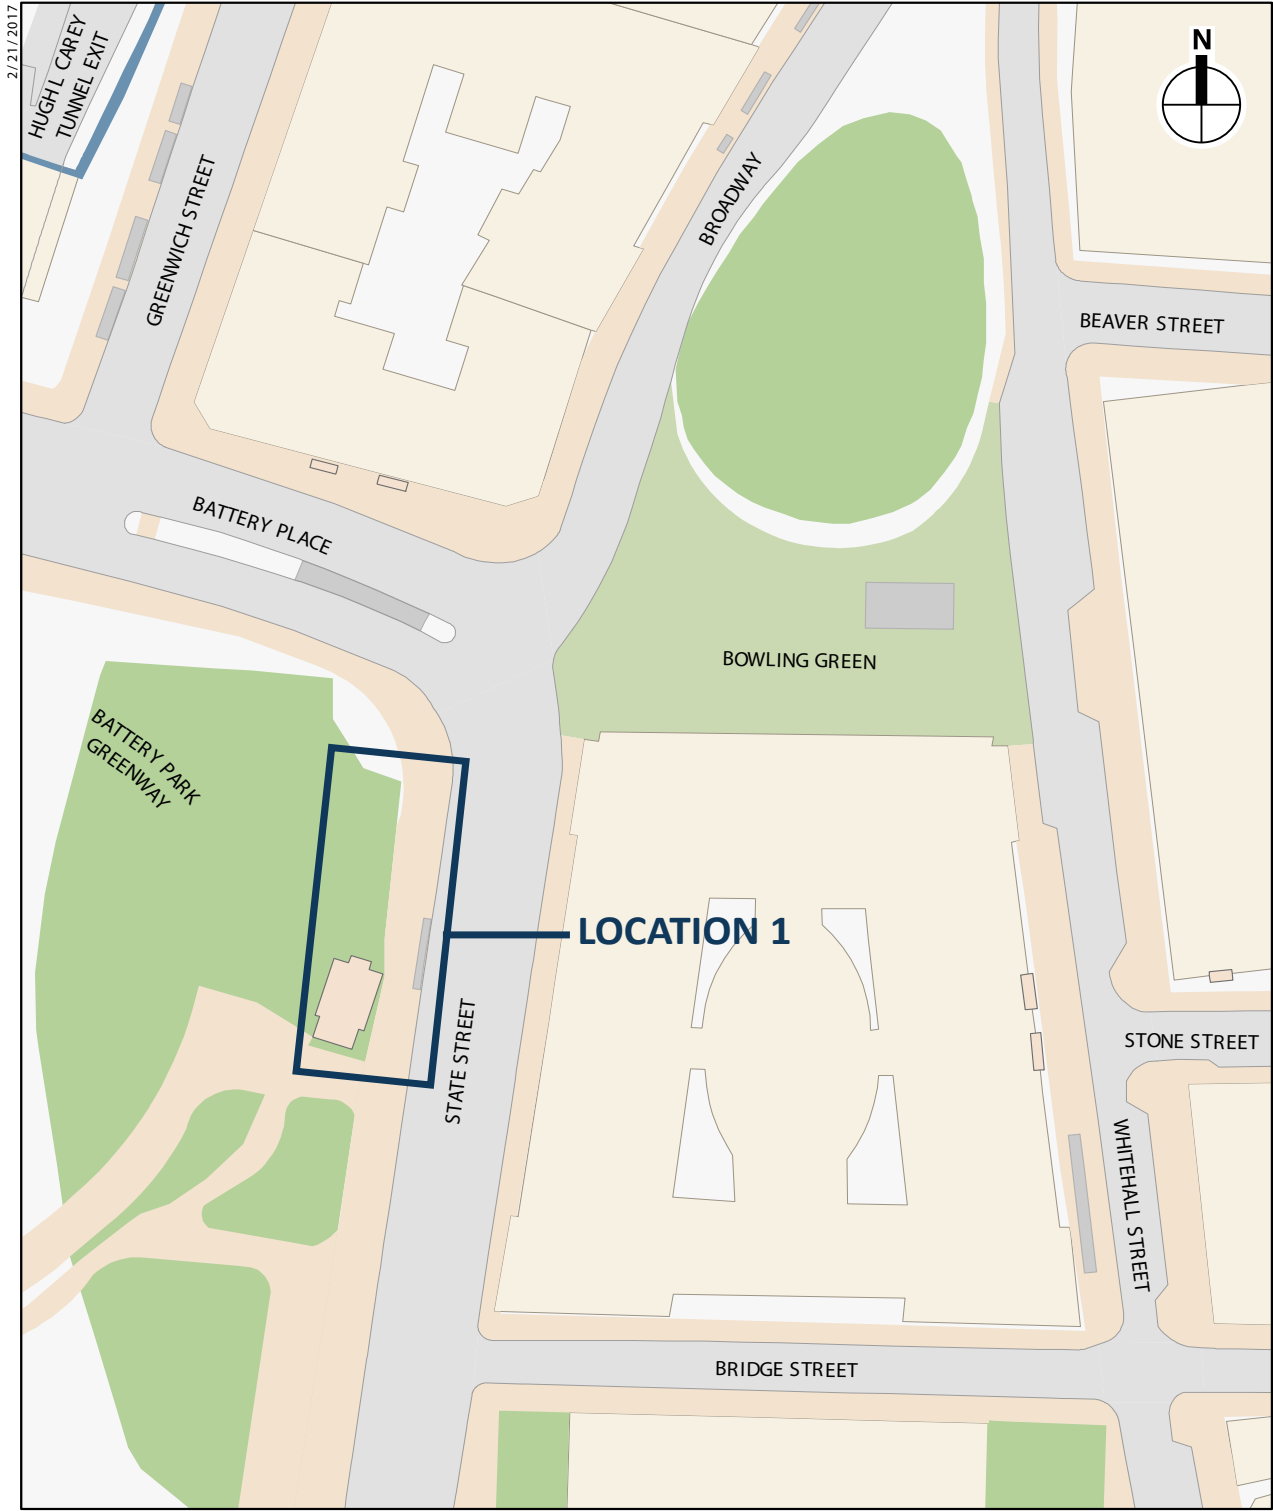
**Figure 3: Sidewalk Analysis Location 1**

Location 1 is a sidewalk immediately adjacent to a paved pedestrian plaza at the north-east corner of Battery Park. An aboveground structure that provides access to the Bowling Green subway station sits within the pedestrian plaza. The subway entrance structure creates a pinch point in the pedestrian space which is 21 feet wide at its narrowest point. The presence of light poles, grates, a fire hydrant and other physical obstructions within the sidewalk area causes the effective width of the pedestrian travel zone to be 14.5 feet at the narrowest point.

The presence of the subway access at Location 1 adds to the number of pedestrians in the immediate area and complicates the pedestrian traffic patterns. Tour buses were observed stopping to drop off and pick up customers near subway entrance structure entrance and immediately to its north and south. During the preliminary field visit, several ticket vendors were actively selling bus tickets.

In all observation periods during the weekday data collection, ticket vendor activity was observed to be infrequent and did not factor as an obstruction to pedestrian flows. During all observation periods, most of the ticket vendor and tour bus employees were positioned at the point where the sidewalk is wider and were not observed to create choke points. However, tour bus queuing behavior was observed to occasionally but noticeably restrict the walking space available at the narrowest point of this sidewalk. Queues were observed to occupy approximately one-third of the total width of the sidewalk, as shown in **Image 1** and **Image 2**. Tour bus passengers who disembarked in large groups (platoons) contributed to additional sidewalk congestion. After accounting for the obstructions created by the queuing behavior and shy distance, the effective width of the sidewalk would be approximately 11.5 feet.

During the weekend day data collection, it was also observed that ticket vendor activity was infrequent and did not factor as an obstruction to pedestrian flows, but that tour bus queuing behavior resulted in an even more restrictive choke point near the narrowest point of the sidewalk, as queues were organized perpendicularly to the sidewalk, occupying approximately two-thirds of the available sidewalk space, as shown in **Image 3**. Tour bus passengers who disembarked in platoons also contributed to additional sidewalk congestion, occupying a similar proportion of the available sidewalk space, as shown in **Image 4**. After accounting for the obstructions created by this queuing behavior on the weekend day, the effective width of the sidewalk would be approximately 7 feet.

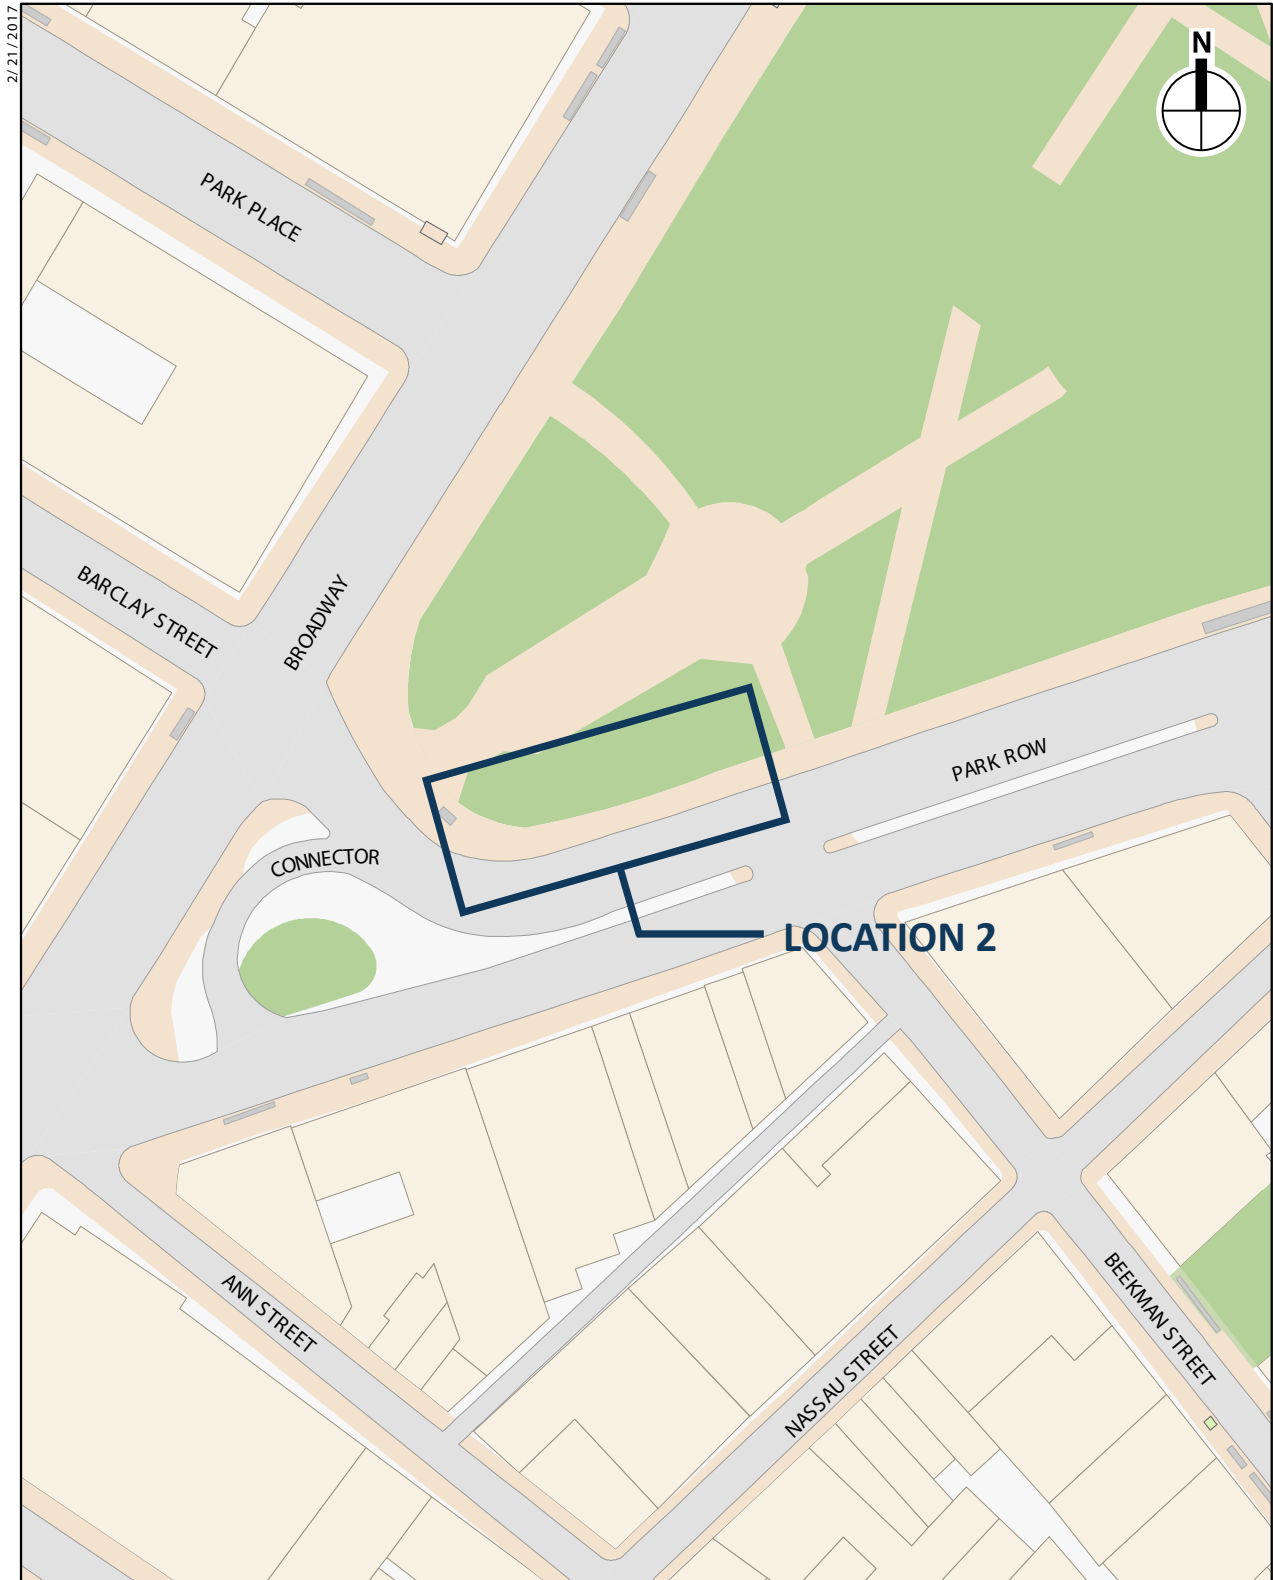
Figure 4: Sidewalk Analysis Location 2

During the weekday data collection period, ticket vending activities were not observed to be frequent; however tour bus company employees were present. The employees appeared to be assisting with tour bus queuing and boarding which reduced the queues obstructive effects on pedestrian flows. During the weekday midday peak hour, tour bus queuing was observed to be infrequent, with the typical condition shown in **Image 5**. During the weekday PM peak hour, tour bus queuing was observed to be much more persistent, and did obstruct to pedestrian flows at the narrowest point of the sidewalk.

Queues were typically organized along the fence side of the sidewalk at the narrowest point. Traffic signs located adjacent to the curb at this location further reduced the available pedestrian space. As shown in **Image 6**, the queuing area obstructed roughly half of the remaining effective width. This resulted in significant limitation of walking space for pedestrians. **Image 7** shows the sidewalk condition when the queue snakes around and blocks the entire width of the sidewalk during bus boarding. These photos illustrate a temporary condition that would last for several minutes during bus boarding. After accounting for this observed queuing behavior, the effective width of the sidewalk available for pedestrian flow would be 2 feet in the weekday PM peak hour, but would remain at 7.5 feet in the weekday midday peak hour.

Similar to the weekday, there was little vendor activity however tour bus employees were observed to be active in assisting with the bus queuing. As was observed on the weekday the employees' efforts seem to minimize any obstruction to pedestrian flows. Queuing behavior observed during the weekend day, shown in **Image 8**, was similar to that of the weekday PM peak period. After accounting for the queuing area, the physical obstructions, and shy distance, the effective width of the sidewalk available for pedestrian flow would be 2 feet during the weekend day peak hour.

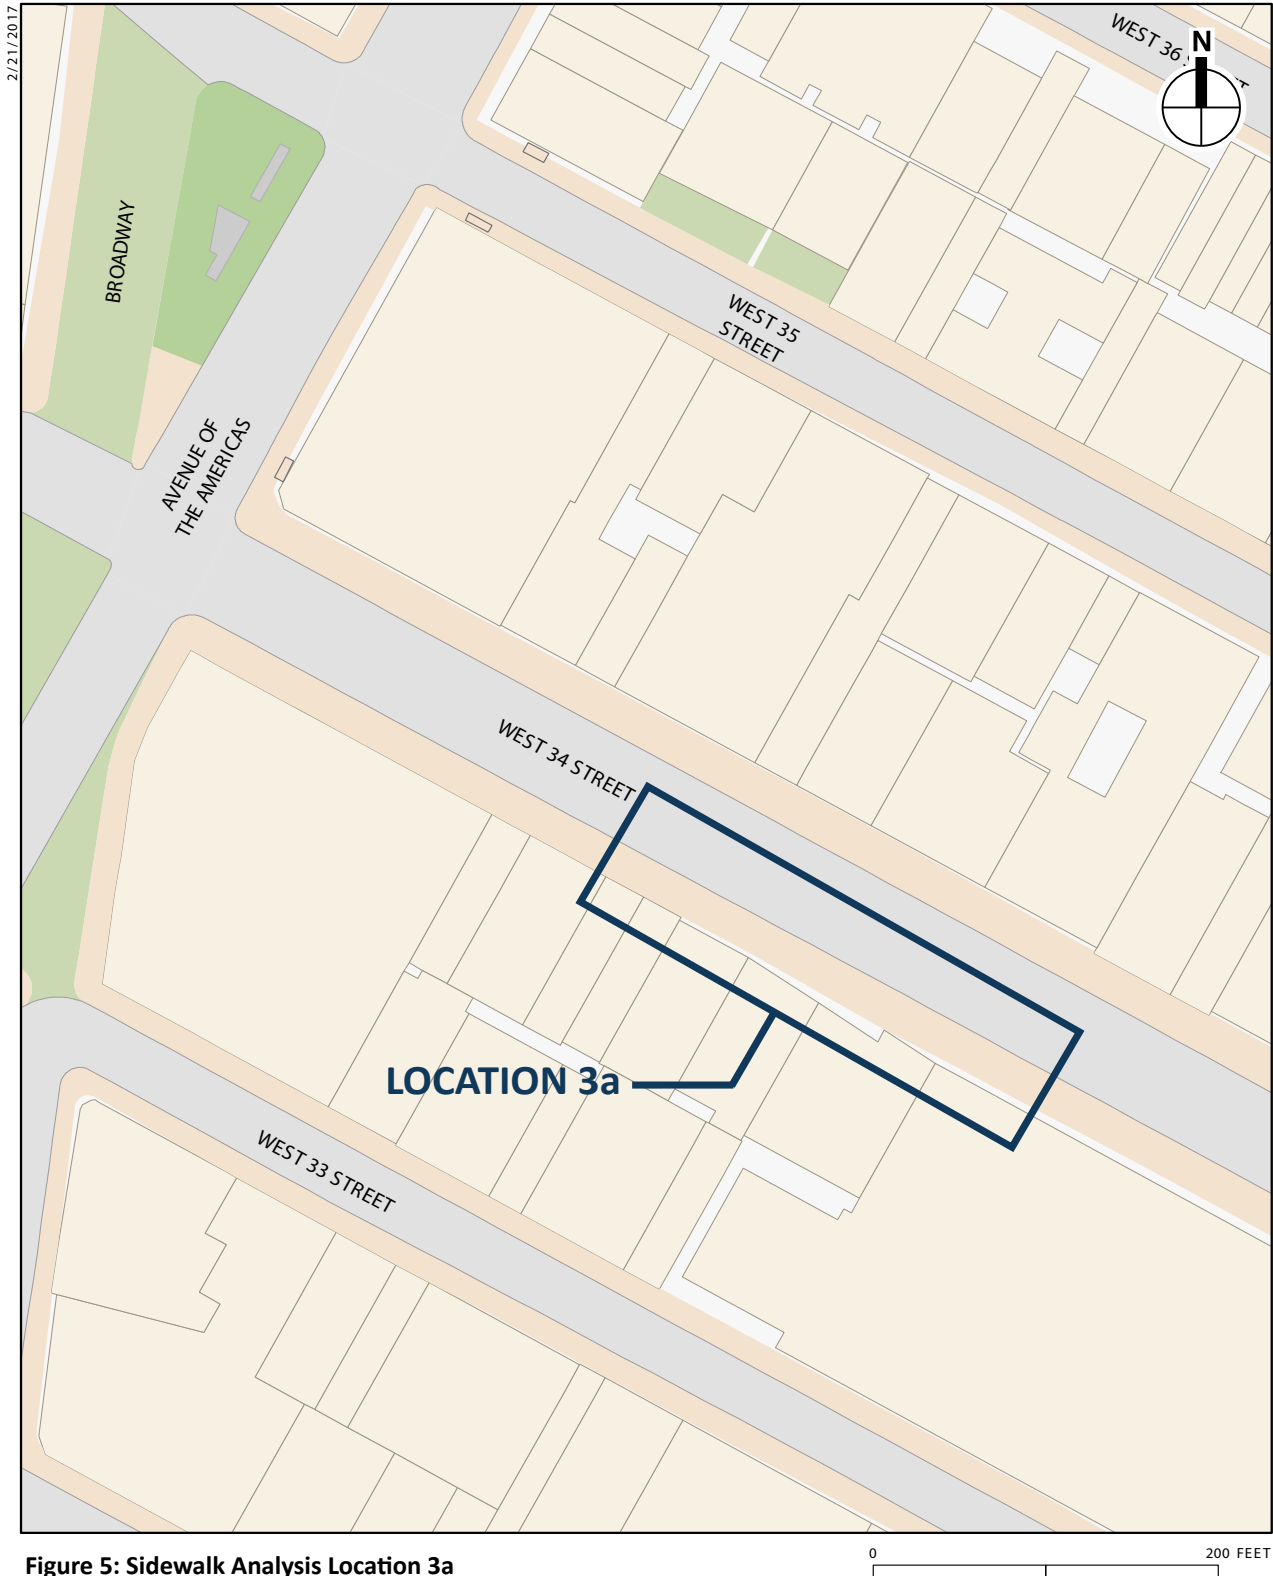
Figure 5: Sidewalk Analysis Location 3a

Notable ticket vendor behavior included clustering around a group of tourists when they stop to talk to one vendor. The number of ticket vendors clustering around prospective customers ranged from three to six. The number of prospective customers observed to be in the cluster causing the sidewalk obstructions ranged from four to thirteen. On several occasions during the weekday data collection periods clustering of vendors caused obstructions that lasted up to 15 minutes. Clustering was observed once during the weekend day, lasting for a six minute period when roughly six ticket vendors were clustered around approximately six prospective customers.

When the ticket purchase transaction was complete, the customers would usually move to the edges of the sidewalk. Typically the queues formed near the curb, occupying the space between planters and other physical elements which is not used for pedestrian flow. During all observation periods, queues would occasionally form perpendicular to the sidewalk, causing obstruction to the pedestrian flow.

During the weekend day peak hour tour bus queuing and ticket vendor activities combined to create choke points along this sidewalk. With the queuing behavior, which created an approximately 4-foot obstruction, the effective width of the sidewalk was reduced to 10.5 feet. When both queuing and vendor activities took place simultaneously the effective width for pedestrian flow was reduced to approximately 4.5 feet. At times during the weekday midday peak hour, the groups of tourists and ticket vendors became quite large and occupied up to two-thirds of the available sidewalk space. During the weekend peak hour ticket vendors and customers were observed to occupy approximately one-third of the available sidewalk space. During the weekday PM peak hour, some pedestrians were observed to be walking in the bus lane due to the congested conditions and tour bus/ticket vendor activities on the sidewalk.

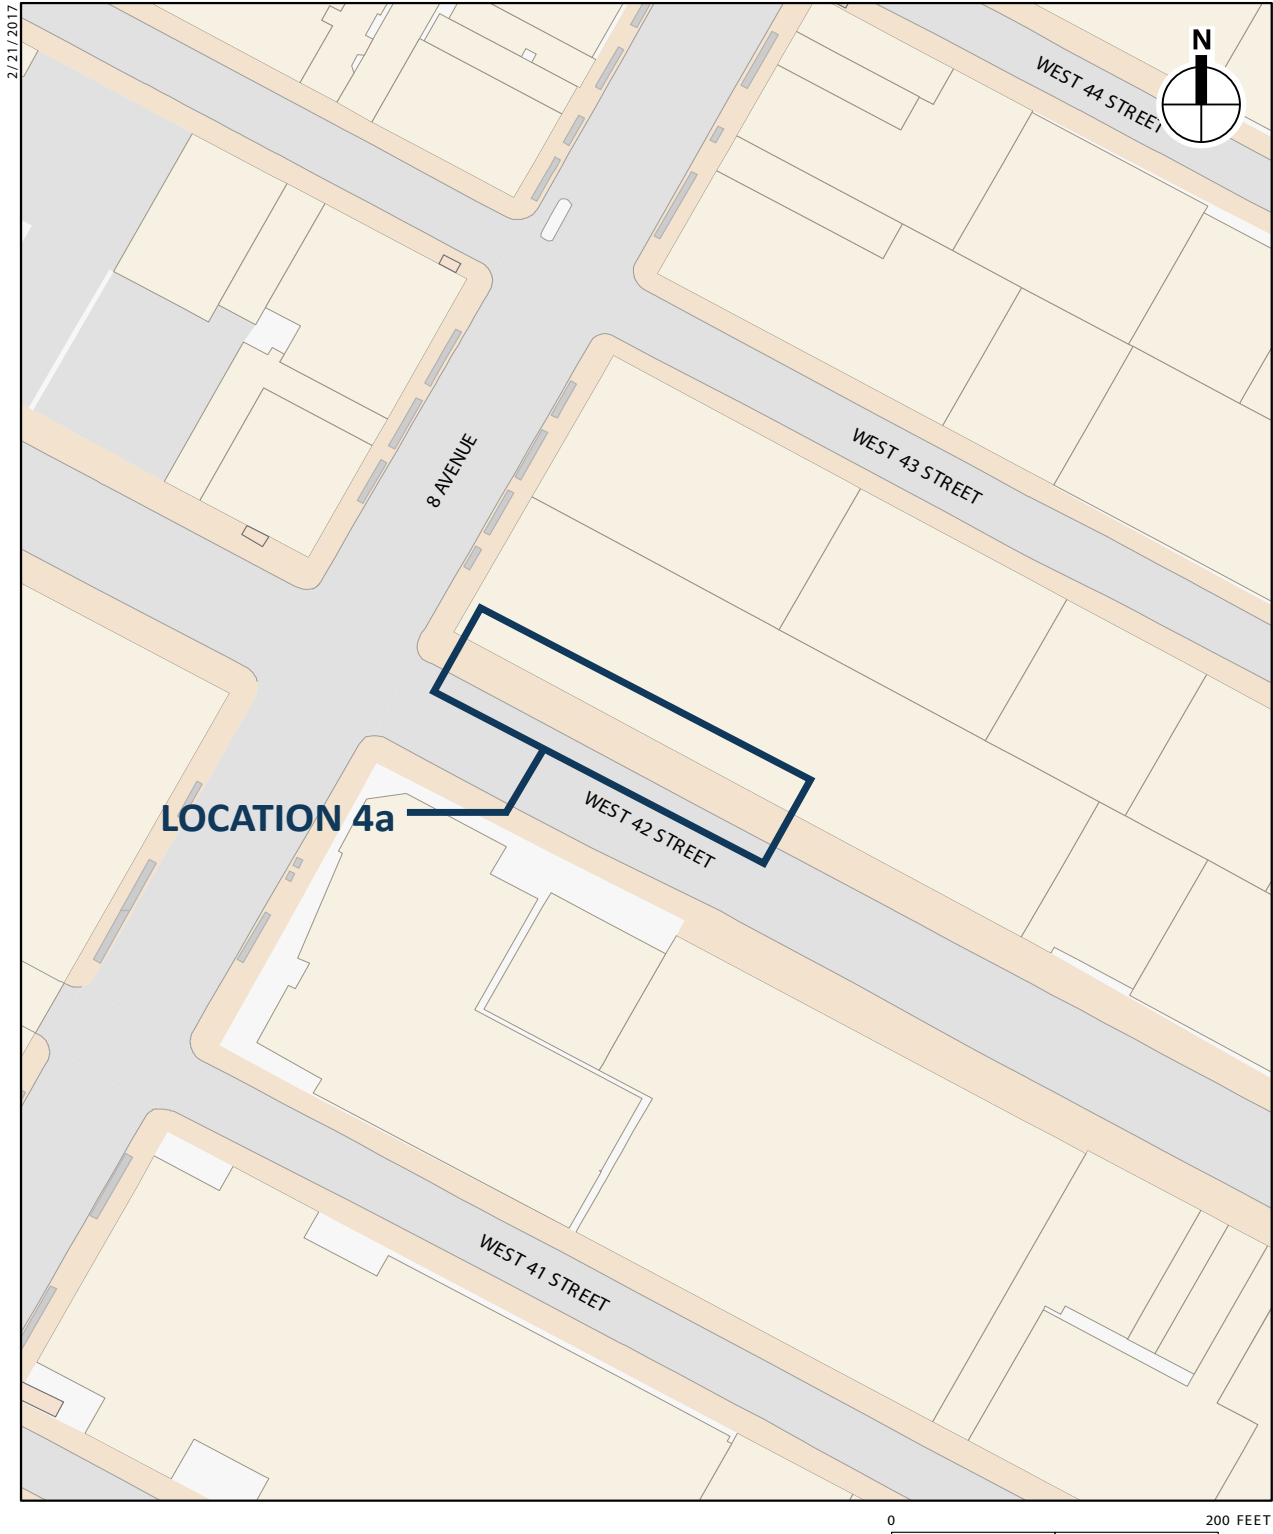
Figure 7: Sidewalk Analysis Location 4a

During the preliminary field visit, ticket vendor were observed in front of the Five Guys Burger and Starbucks retail frontages as well as near the Big Bus Tours, The Ride, and Gray Line tour bus stops (**Image 18**). Vendors were observed to actively stop pedestrians and temporarily created a choke point in the sidewalk by doing so. Movable metal barricades had been placed by the curb provide a separation for tour bus queuing which formed parallel to the curb. This appeared to alleviate potential obstruction to pedestrian flows. After accounting for the passenger queuing area and other physical obstructions the effective width of the sidewalk for pedestrian travel was approximately 8 feet.

Typical sidewalk conditions observed at this location during the data collection are depicted in the photos and video screenshots in **Images 19 through 22**. Five or six vendors were operating at this location during the weekday midday peak period, but were not observed to consistently obstruct pedestrian flows. Large groups were observed to gather for two different bus companies' services, Big Bus NYC and The Ride Bus. Queues were observed most frequently from 11 AM to 12 PM. Queuing behavior for tour buses on this sidewalk consisted of groups waiting near the metal barricades for the bus to arrive, then queuing on the curb side of the metal barricades to board the bus. Queues were observed to be set up on both the inside and outside of the metal barricades. A school bus was also observed on Wednesday, December 21 to use the tour bus stop to pick up passengers.

The sidewalk was much more heavily utilized in the weekday PM peak period than during the midday peak period, with many commuters heading westbound in the direction of the Port Authority Bus Terminal. Bus queuing was also observed, primarily from around 5:15 PM and 5:30 PM, with similar behavior, as passengers would wait by the curb near the metal barricades to board the bus. Vendors and promoters not associated with the tour bus companies were observed to walk up and down the sidewalk handing out flyers.

Two groups of vendors were observed to be active during the weekend day data collection period: Big Bus NYC and Gray Line. The queueing behavior for the tour buses was relatively consistent in its method of organization during the weekend day as well, with the metal barricades set up and the lines neatly organized by the tour bus staff, not interfering with pedestrian flows. The Gray Line vendors were stationed closer to the intersection of West 42nd Street and Eighth Avenue, which were observed to cause occasional issues with pedestrian flows when the volume of pedestrians increased later in the day. Ticket vendor activities for Big Bus NYC were observed to be less prevalent later in the day, when pedestrian traffic increased.

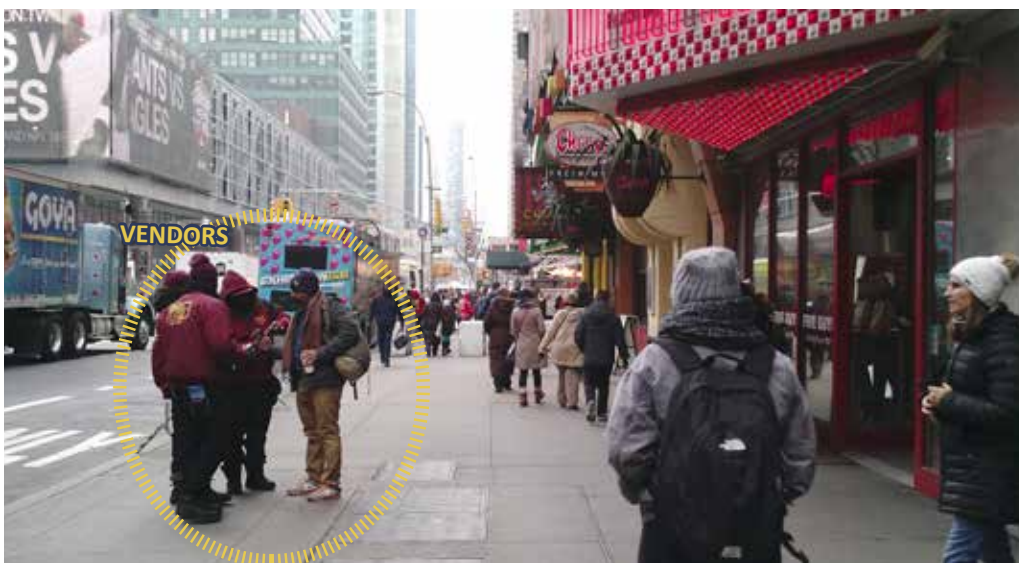
Wednesday December 21st, 12:58 PM

**Image 19: Weekday midday peak hour**

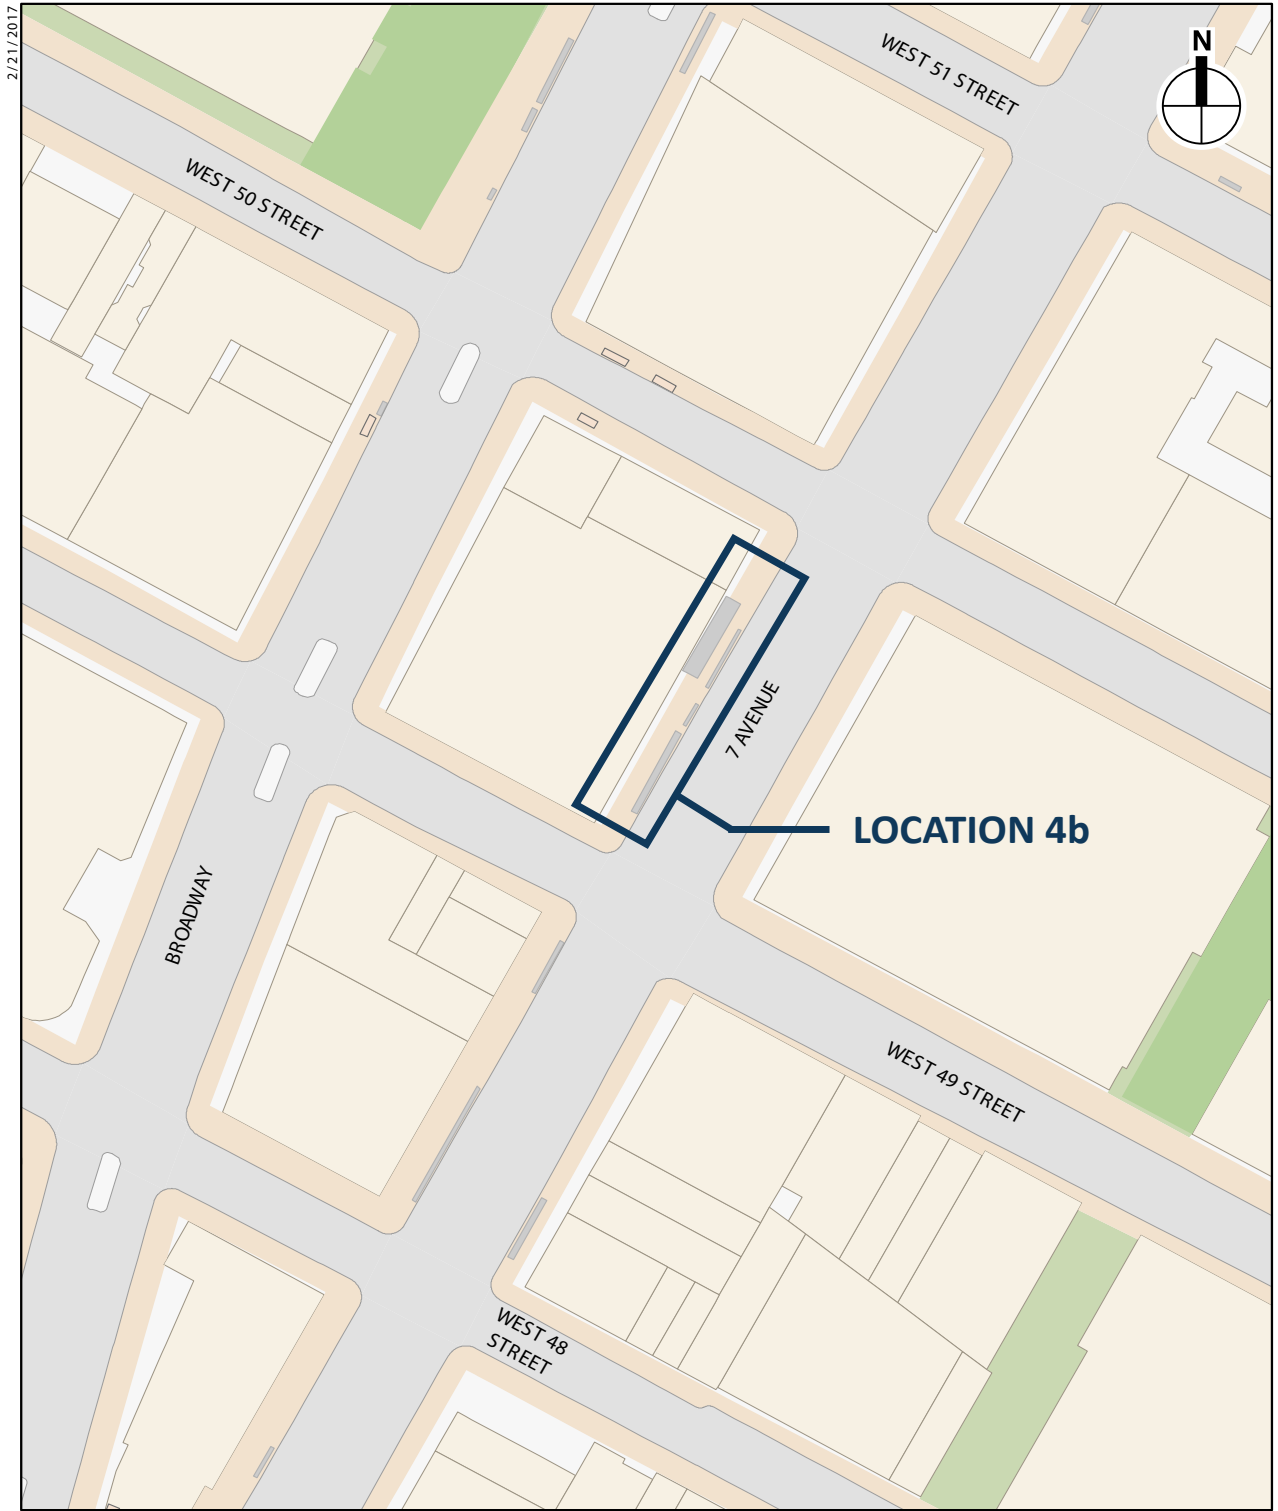
Figure 8: Sidewalk Analysis Location 4b

Queuing behavior in the weekday PM peak periods were similar to that observed to the weekday midday peak period, with tour bus personnel organizing the queues parallel to the curb. This obstruction did not hinder pedestrian flow in the midday peak hour. In the PM and weekend peak hours when pedestrian volumes and activities were much greater there was some effect on pedestrian flow. Overall, this location is very busy on weekdays due to various commercial activities, including Broadway show promoters and costumed characters stopping and talking to pedestrians in the middle of the sidewalk.

During the weekend data collection period on Sunday, January 1st, tour bus activities were observed to have a greater effect on the sidewalk's capacity, as tour bus queues were observed to be longer and occupied nearly a quarter of the sidewalk width. Queuing conditions were also observed to be more sustained than during the weekday: bus queues were observed to occur throughout the day. Some tour bus staff or passengers were also observed to stand on the building side. The sidewalk was significantly congested during the weekend peak hour of 5:00 PM to 6:00 PM, primarily due to the volume of pedestrian activity and the limited availability in sidewalk space caused by tour bus queuing activities.

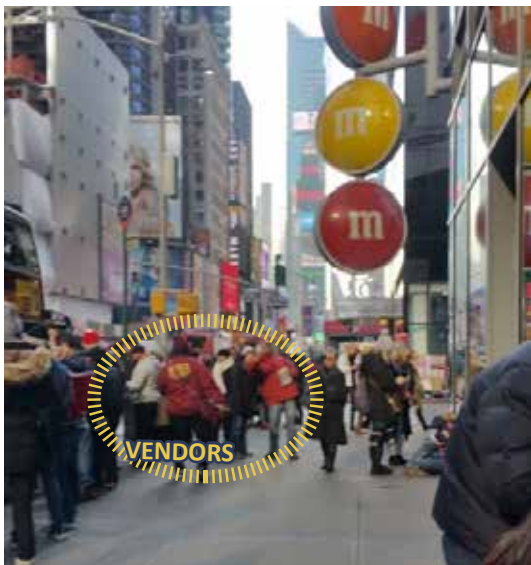
Thursday, December 22nd, 12:45 PM

**Image 24: Weekday midday peak hour.**

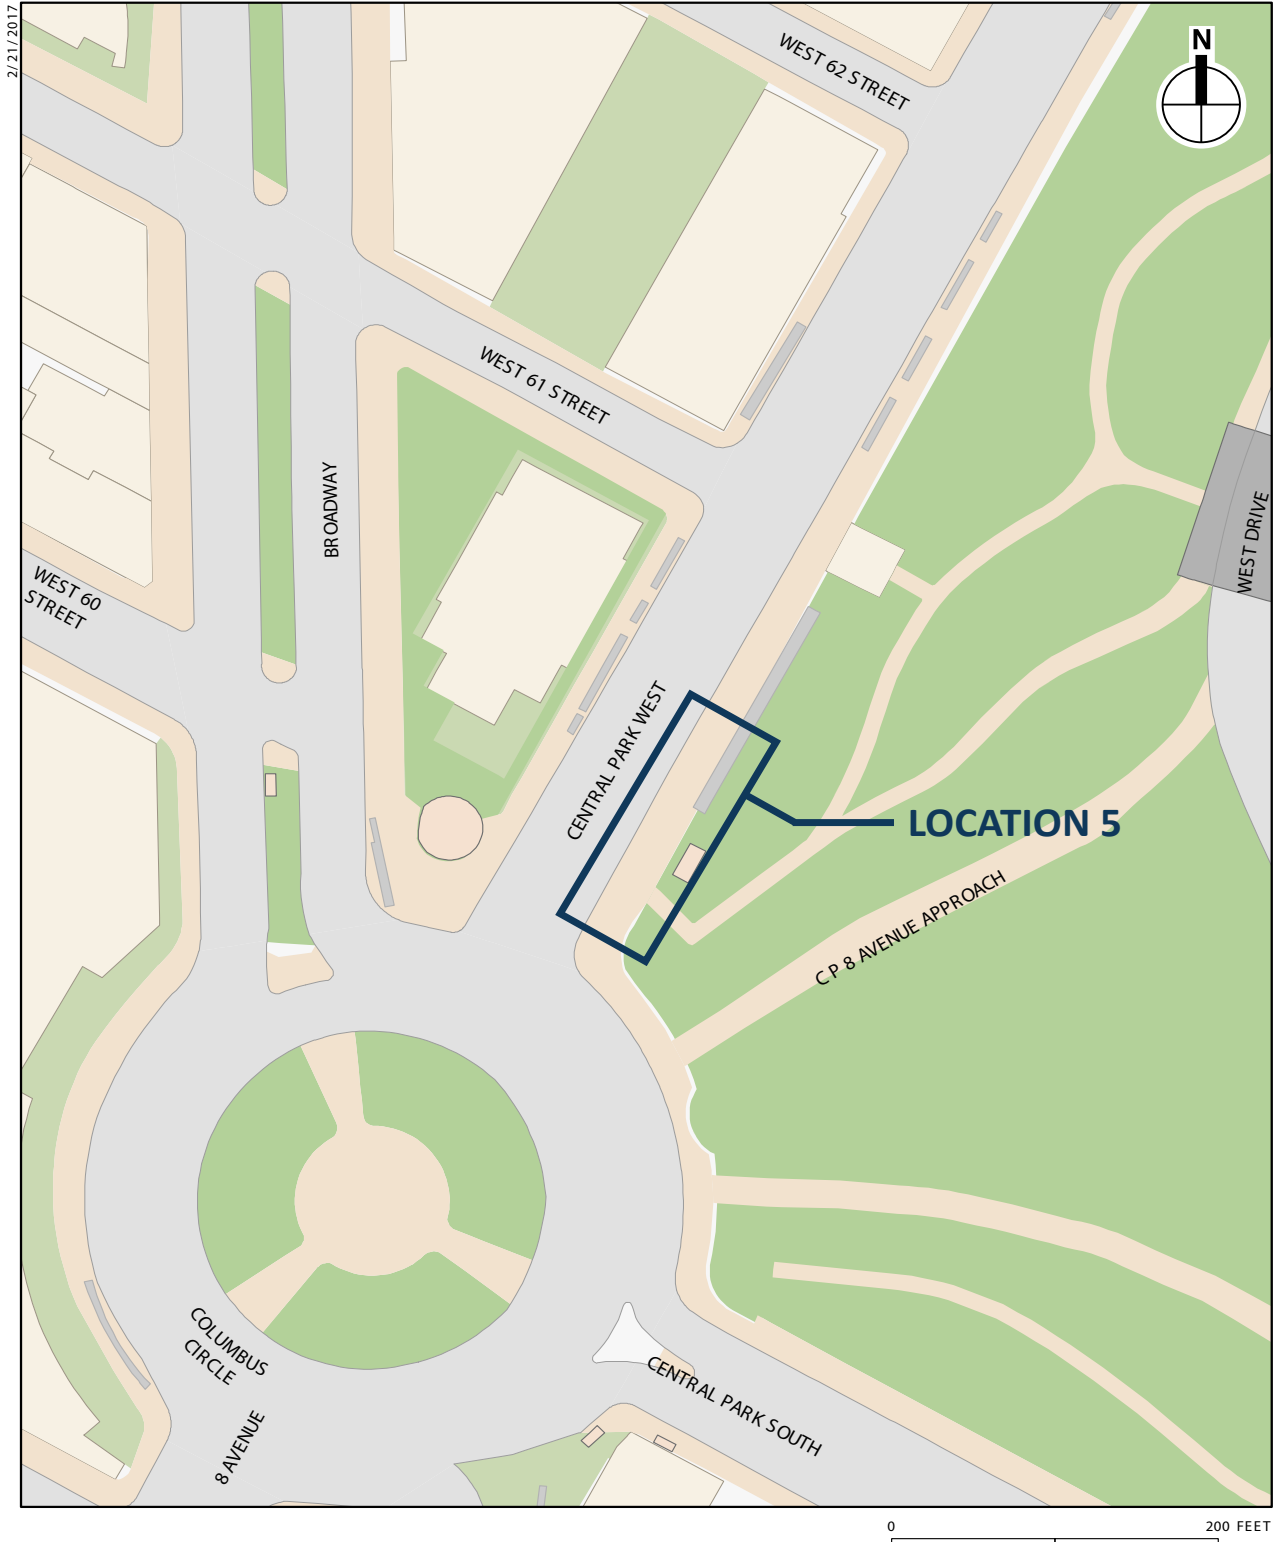
Figure 9: Sidewalk Analysis Location 5

Queuing behavior at this location was observed to be partially or completely obstructed the pedestrian flow frequently. This would occur due to the location of the queues, at the narrowest point of the sidewalk segment, and due to the fact that the queues would form perpendicular to pedestrian flow. This behavior, illustrated **Images 30 through 32**, was observed during the midday peak periods for both weekdays and the weekend day. Choke points were temporarily created for both the sidewalk pedestrian flow and the pedestrian access to the adjacent subway station. As shown in **Image 33**, this condition was not observed during the weekday PM peak period, as the volume of tour bus activity diminished significantly during that period. After accounting for this condition, the effective width of the sidewalk was reduced to 2 feet in the weekday midday and weekend day peak hours. The effective width of the sidewalk was reduced to 7.5 feet in the weekday PM peak hour after accounting for the permanent kiosk, metal barricades set up for queuing, and shy distance.

- Regulate bus queuing activity.
  - Designate locations where tour bus queuing is permitted which reflect existing regulations for minimum distance from subway station entrances and exits. These locations should be areas with wider sidewalks and minimal permanent obstacles.

- Queuing should be oriented along the curbline (parallel to the flow of traffic at locations abutting active roadways). Examples of how this is implemented are shown in **Images 34 and 35**, which depict how bus queuing is organized at an intercity bus stop on West 30th Street between Seventh and Eighth Avenues. Queuing is organized along the curb and does not measurably disrupt sidewalk operations.

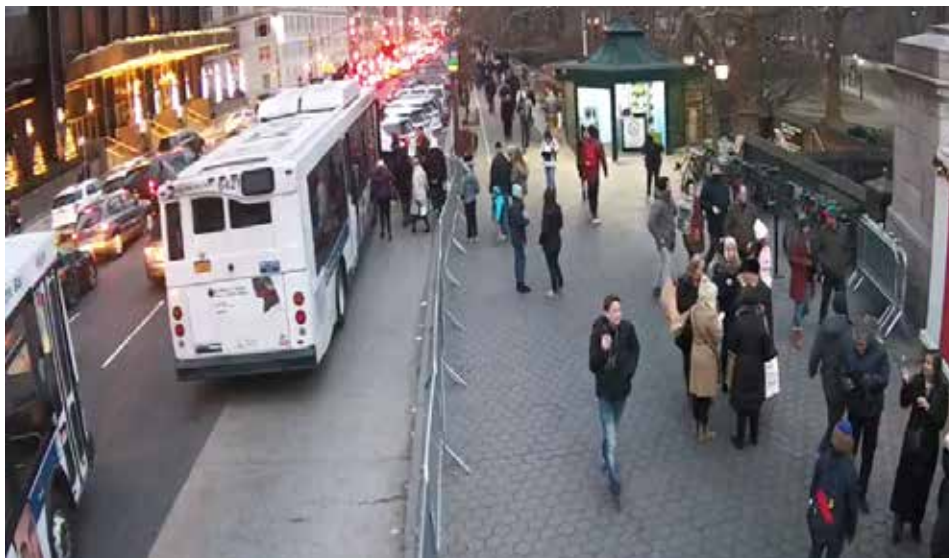
Wednesday, December 21. 4:37 PM

**Image 33: Weekday PM peak hour, no queues or vendors present.**

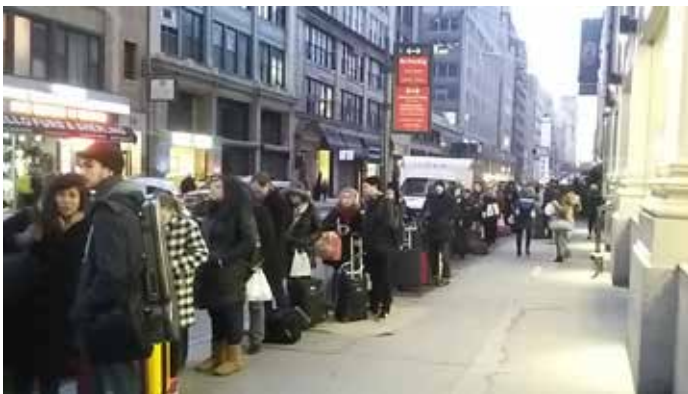
Image 34: Example of bus queuing organized in sidewalk furniture zone.

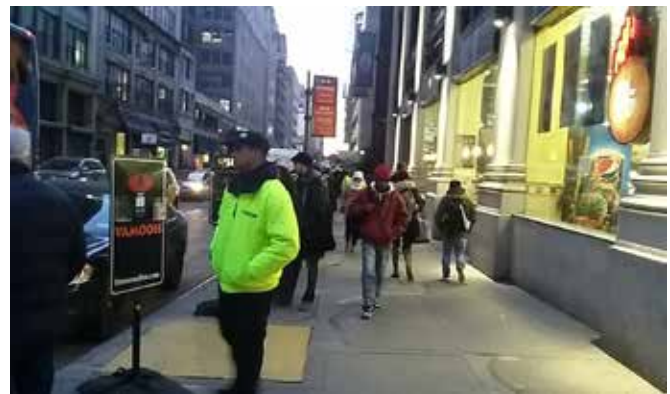
Image 35: Example of bus queuing organized in sidewalk furniture zone.
